**ANALYTICAL EVALUATION OF SELECTED CONCRETE
STRUCTURES AGAINST EARTHQUAKES IN TURKEY**

**M.Sc. THESIS IN
CIVIL ENGINEERING**

FERİDE CEYLAN

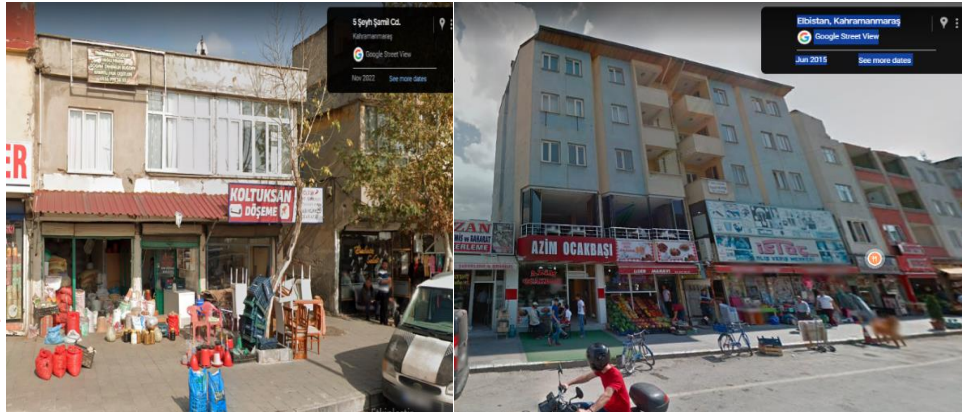
Figure 4. 8: Soft/weak floor condition of the examined structures

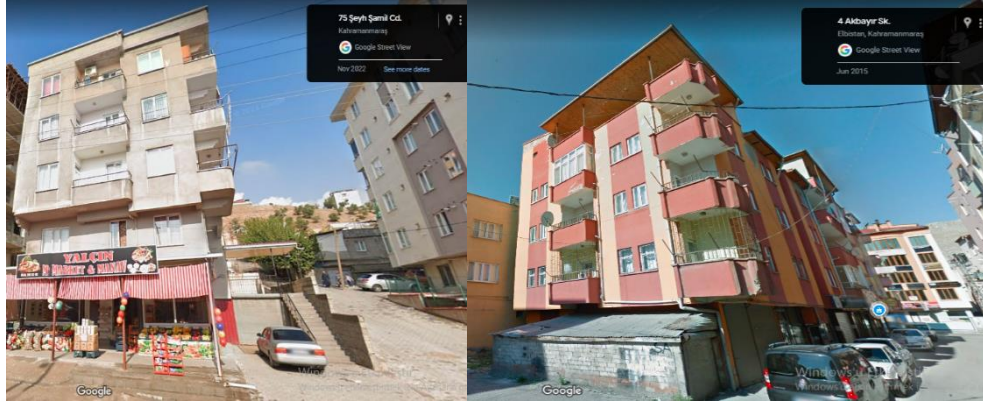
Figure 4. 9: Severe protrusion conditions in the examined structures

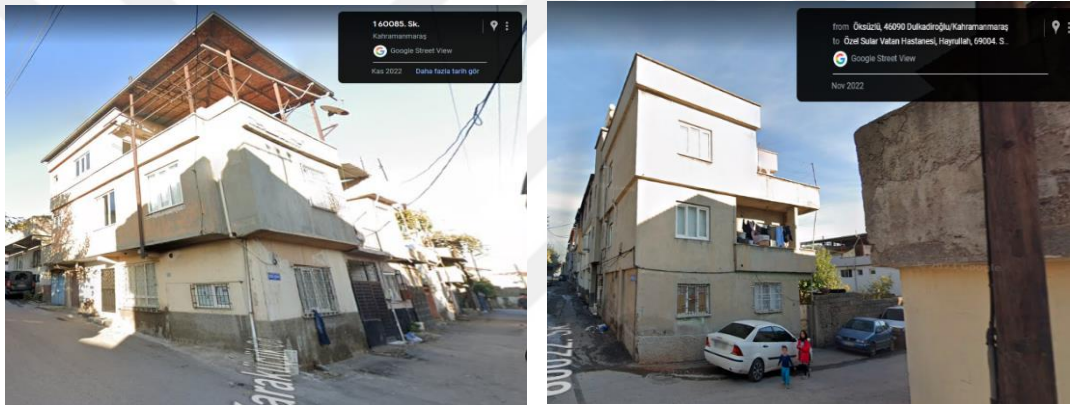
Figure 4. 12: Vertical irregularity of the examined structures

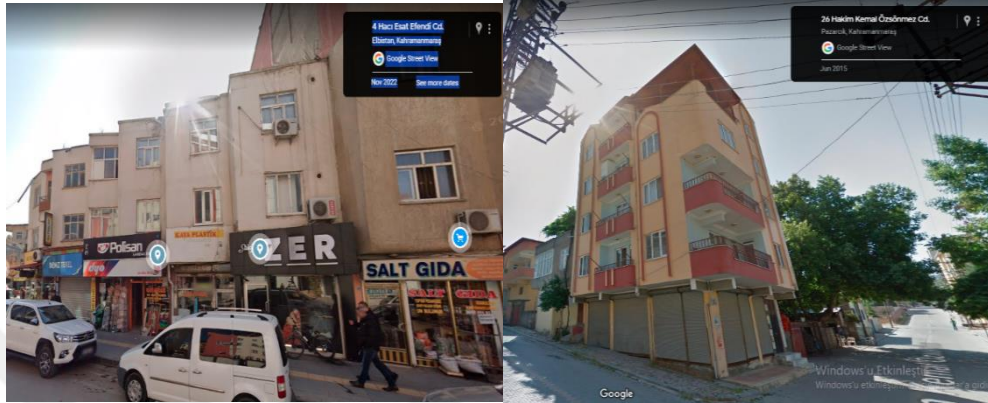
Figure 4. 14: Irregularity in the plan of the buildings examined

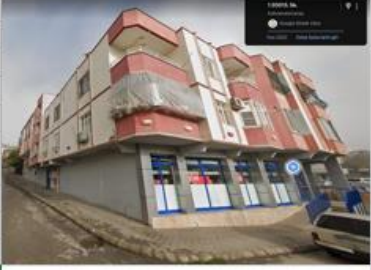
33. YAPI	kat sayısı	3			YSP(BAÇP)	BDP
		deprem sınıfı puanı	2. bölge		100		42
		yumuşak kat	var	1	20		
		bina kalitesi	iyi	0	10		
		ağır çıkma	var	1	20		
		yapı nizamı	bitişik	1	10		
		düşeyde düz.	yok	0	10		
		plada düz.	yok	0	10		
		zemin eğimi	var	1	3		
kısa kolon	var	1	5

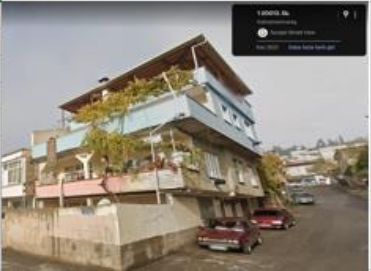
34. YAPI	kat sayısı	4			YSP(BAÇP)	BDP
		deprem sınıfı puanı	2. bölge		90		15
		yumuşak kat	yok	0	30		
		bina kalitesi	iyi	0	15		
		ağır çıkma	var	1	30		
		yapı nizamı	bitişik	1	15		
		düşeyde düz.	var	1	15		
		plada düz.	var	1	10		
		zemin eğimi	yok	0	3		
kısa kolon	var	1	5

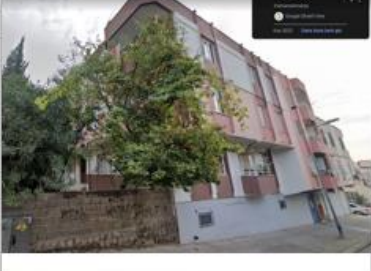
35. YAPI	kat sayısı	4			YSP(BAÇP)	BDP
		deprem sınıfı puanı	2. bölge		90		42
		yumuşak kat	yok	0	30		
		bina kalitesi	iyi	0	15		
		ağır çıkma	var	1	30		
		yapı nizamı	bitişik	1	10		
		düşeyde düz.	yok	0	15		
		plada düz.	yok	0	10		
		zemin eğimi	var	1	3		
kısa kolon	var	1	5

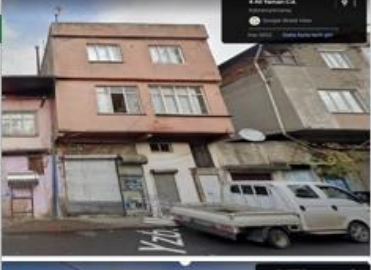
36. YAPI	kat sayısı	3			YSP(BAÇP)	BDP
		deprem sınıfı puanı	2. bölge		100		30

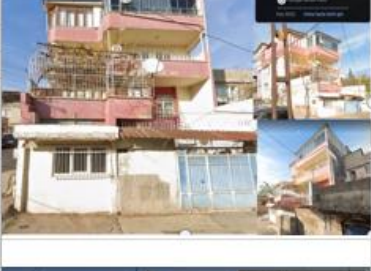
37. YAPI	kat sayısı	4			YSP(BAÇP)	BDP
		deprem sınıfı puanı	2. bölge		90		30
		yumuşak kat	yok	0	30		
		bina kalitesi	orta	1	15		
		ağır çıkma	yok	0	30		
		yapı nizamı	bitişik	1	15		
		düşeyde düz.	var	1	15		
		plada düz.	var	1	10		
		zemin eğimi	yok	0	3		
kısa kolon	var	1	5

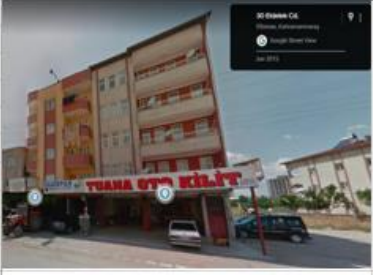
41. YAPI	kat sayısı	5			YSP(BAÇP)	BDP
		deprem sınıfı puanı	2. bölge		80	65	85
		yumuşak kat	var	1	30		
		bina kalitesi	orta	1	25		
		ağır çıkma	yok	0	30		
		yapı nizamı	bitişik	0	10		
		düşeyde düz.	yok	0	15		
		plada düz.	yok	0	10		
		zemin eğimi	yok	0	3		
kısa kolon	var	1	5

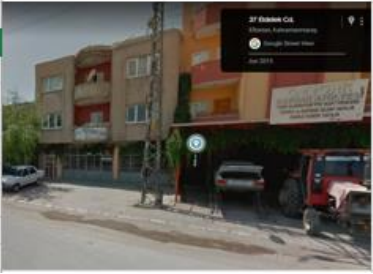
42. YAPI	kat sayısı	3			YSP(BAÇP)	BDP
		deprem sınıfı puanı	2. bölge		100		30
		yumuşak kat	var	1	20		
		bina kalitesi	kötü	2	10		
		ağır çıkma	var	1	20		
		yapı nizamı	bitişik	1	5		
		düşeyde düz.	yok	0	10		
		plada düz.	yok	0	10		
		zemin eğimi	yok	0	3		
kısa kolon	var	1	5

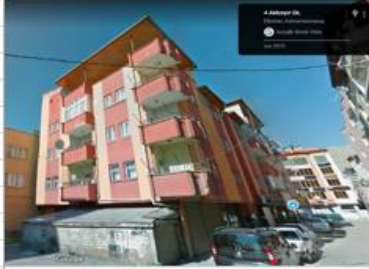
43. YAPI	kat sayısı	5			YSP(BAÇP)	BDP	
		deprem sınıfı puanı	2. bölge		120		65	
		yumuşak kat	var	1	10			
		bina kalitesi	orta	1	10			
		ağır çıkma	var	1	10			
		yapı nizamı	bitişik	1	10			
		düşeyde düz.	var	1	5			
		plada düz.	var	1	5			
		zemin eğimi	yok	0	3			
		kısa kolon	var	1	5

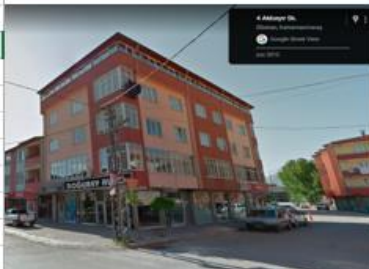
44. YAPI	kat sayısı	5			YSP(BAÇP)	BDP	
		deprem sınıfı puanı	2. bölge		80	55	35	
		yumuşak kat	var	1	30			
		bina kalitesi	orta	1	25			
		ağır çıkma	var	1	30			
		yapı nizamı	bitişik	1	10			
		düşeyde düz.	yok	0	15			
		plada düz.	yok	0	10			
		zemin eğimi	yok	0	3			
		kısa kolon	var	1	5

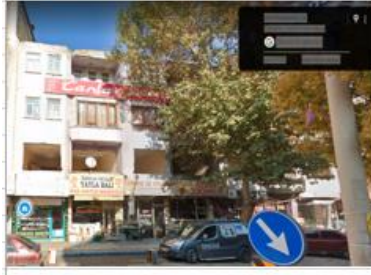
49. YAPI	kat sayısı	4			YSP(BAÇP)	BDP
	deprem sınıfı puanı	2.bölge		90		25
	yumuşak kat	var	1	30		
	bina kalitesi	kötü	2	15		
	ağır çıkma	yok	0	30		
	yapı nizamı	bitişik	1	0		
	düşeyde düz.	yok	0	15		
	plada düz.	yok	0	10		
	zemin eğimi	yok	0	3		
	kısa kolon	var	1	5

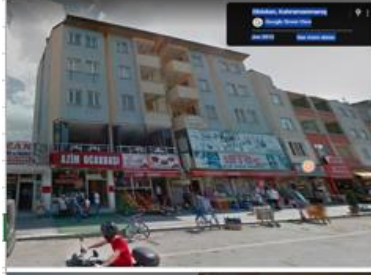
50. YAPI	kat sayısı	5			YSP(BAÇP)	BDP
	deprem sınıfı puanı	2. bölge		80	65	105
	yumuşak kat	var	1	30		
	bina kalitesi	iyi	0	25		
	ağır çıkma	yok	0	30		
	yapı nizamı	bitişik	1	5		
	düşeyde düz.	yok	0	15		
	plada düz.	yok	0	10		
	zemin eğimi	yok	0	3		
	kısa kolon	var	1	5

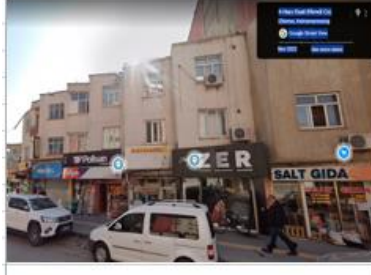
51. YAPI	kat sayısı	3			YSP(BAÇP)	BDP
	deprem sınıfı puanı	2. bölge		100		15
	yumuşak kat	var	1	20		
	bina kalitesi	kötü	2	10		
	ağır çıkma	var	1	20		
	yapı nizamı	bitişik	1	10		
	düşeyde düz.	yok	0	10		
	plada düz.	var	1	10		
	zemin eğimi	yok	0	3		
	kısa kolon	var	1	5

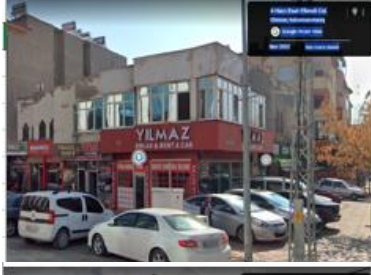
52. YAPI	kat sayısı	2			YSP(BAÇP)	BDP
	deprem sınıfı puanı	2. bölge		120		60
	yumuşak kat	var	1	10		
	bina kalitesi	kötü	2	10		
	ağır çıkma	var	1	10		
	yapı nizamı	bitişik	1	10		
	düşeyde düz.	yok	0	5		
	plada düz.	var	1	5		
	zemin eğimi	yok	0	3		
	kısa kolon	var	1	5

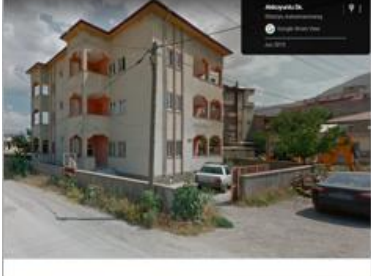
53. YAPI	kat sayısı	4			YSP(BAÇP)	BDP
	deprem sınıfı puanı	2. bölge		90		70
	yumuşak kat	yok	0	30		
	bina kalitesi	orta	1	15		
	ağır çıkma	yok	0	30		
	yapı nizamı	ayrı	0	1		
	düşeyde düz.	yok	0	15		
	plada düz.	yok	0	10		
	zemin eğimi	yok	0	3		
	kısa kolon	var	1	5

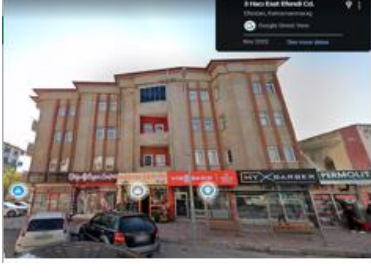
54. YAPI	kat sayısı	4			YSP(BAÇP)	BDP
	deprem sınıfı puanı	2. bölge		90	75	75
	yumuşak kat	var	1	30		
	bina kalitesi	orta	1	15		
	ağır çıkma	var	1	30		
	yapı nizamı	ayrık	0	10		
	düşeyde düz.	yok	0	15		
	plada düz.	var	1	10		
	zemin eğimi	yok	0	3		
	kısa kolon	var	1	5

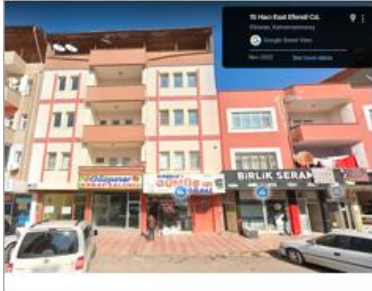
55. YAPI	kat sayısı	5			YSP(BAÇP)	BDP
	deprem sınıfı puanı	2. bölge		80	65	55
	yumuşak kat	var	1	30		
	bina kalitesi	iyi	0	25		
	ağır çıkma	var	1	30		
	yapı nizamı	bitişik	1	0		
	düşeyde düz.	var	1	15		
	plada düz.	var	1	10		
	zemin eğimi	yok	0	3		
	kısa kolon	var	1	5

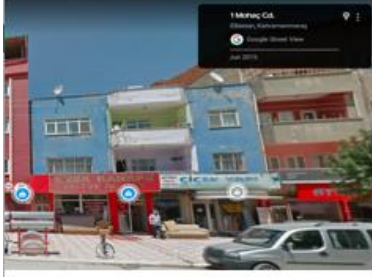
56. YAPI	kat sayısı	3			YSP(BAÇP)	BDP
	deprem sınıfı puanı	2. bölge		100		35
	yumuşak kat	var	1	20		
	bina kalitesi	kötü	2	10		
	ağır çıkma	var	1	20		
	yapı nizamı	bitişik	1	0		
	düşeyde düz.	yok	0	10		
	plada düz.	yok	0	10		
	zemin eğimi	yok	0	3		
	kısa kolon	var	1	5

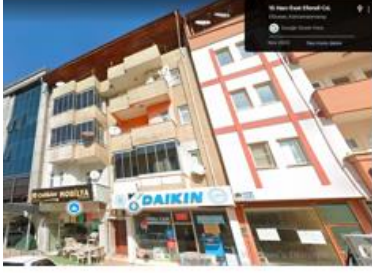
57. YAPI	kat sayısı	5			YSP(BAÇP)	BDP
	deprem sınıfı puanı	2. bölge		80	65	30
	yumuşak kat	var	1	30		
	bina kalitesi	orta	1	25		
	ağır çıkma	var	1	30		
	yapı nizamı	bitişik	1	0		
	düşeyde düz.	var	1	15		
	plada düz.	var	1	10		
	zemin eğimi	yok	0	3		
	kısa kolon	var	1	5

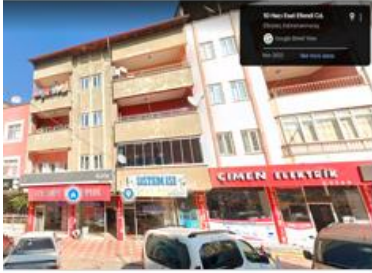
58. YAPI	kat sayısı	4			YSP(BAÇP)	BDP
	deprem sınıfı puanı	2. bölge		90	75	75
	yumuşak kat	var	1	30		
	bina kalitesi	orta	1	15		
	ağır çıkma	var	1	30		
	yapı nizamı	bitişik	1	10		
	düşeyde düz.	yok	0	15		
	plada düz.	yok	0	10		
	zemin eğimi	yok	0	3		
	kısa kolon	var	1	5

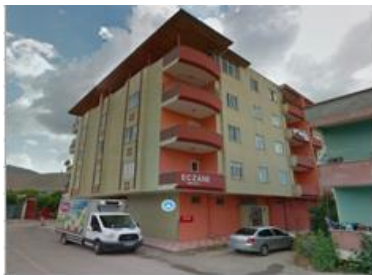
79. YAPI	kat sayısı	5			YSP(BAÇP)	BDP
	deprem sınıfı puanı	2. bölge		80	65	85
	yumuşak kat	yok	0	30		
	bina kalitesi	iyi	0	25		
	ağır çıkma	var	1	30		
	yapı nizamı	ayrık	0	10		
	düşeyde düz.	var	1	15		
	plada düz.	var	1	10		
	zemin eğimi	yok	0	3		
	kısa kolon	var	1	5

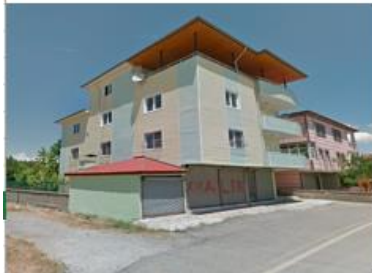
80. YAPI	kat sayısı	4			YSP(BAÇP)	BDP
	deprem sınıfı puanı	2. bölge		90	0	0
	yumuşak kat	var	1	30		
	bina kalitesi	iyi	0	15		
	ağır çıkma	var	1	30		
	yapı nizamı	ayrı	0	1		
	düşeyde düz.	var	1	15		
	plada düz.	var	1	10		
	zemin eğimi	yok	0	3		
	kısa kolon	var	1	5

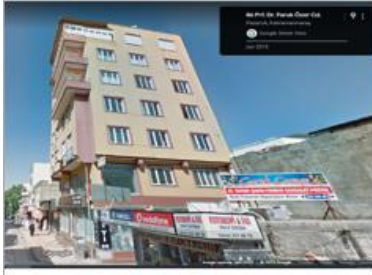
93. YAPI	kat sayısı	7			YSP(BAÇP)	BDP
	deprem sınıfı puanı	1. bölge		50	55	30
	yumuşak kat	var	1	30		
	bina kalitesi	iyi	0	30		
	ağır çıkma	var	1	30		
	yapı nizamı	ayrık	0	1		
	düşeyde düz.	yok	0	15		
	plada düz.	var	1	10		
	zemin eğimi	yok	0	3		
	kısa kolon	var	1	5

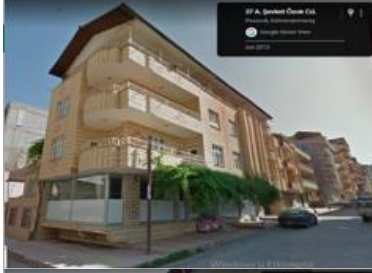
94. YAPI	kat sayısı	4			YSP(BAÇP)	BDP
	deprem sınıfı puanı	1. bölge		70	75	45
	yumuşak kat	var	1	30		
	bina kalitesi	iyi	0	15		
	ağır çıkma	var	1	30		
	yapı nizamı	bitişik	1	10		
	düşeyde düz.	var	1	15		
	plada düz.	var	1	10		
	zemin eğimi	yok	0	3		
	kısa kolon	var	1	5

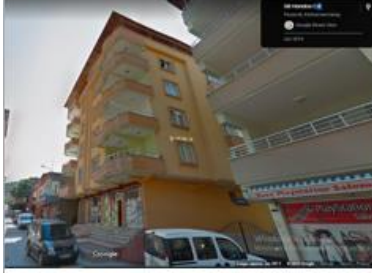
95. YAPI	kat sayısı	6			YSP(BAÇP)	BDP
	deprem sınıfı puanı	1. bölge		50	55	40
	yumuşak kat	var	1	30		
	bina kalitesi	iyi	0	30		
	ağır çıkma	var	1	30		
	yapı nizamı	ayrık	0	1		
	düşeyde düz.	yok	0	15		
	plada düz.	yok	0	10		
	zemin eğimi	yok	0	3		
	kısa kolon	var	1	5

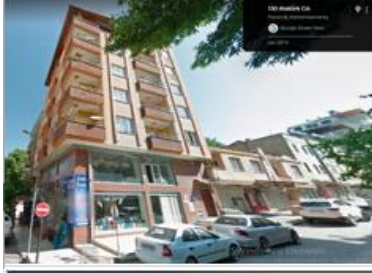
96. YAPI	kat sayısı	7			YSP(BAÇP)	BDP
	deprem sınıfı puanı	1. bölge		50	55	0
	yumuşak kat	var	1	30		
	bina kalitesi	iyi	0	30		
	ağır çıkma	var	1	30		
	yapı nizamı	bitişik	1	15		
	düşeyde düz.	var	1	15		
	plada düz.	var	1	10		
	zemin eğimi	yok	0	3		
	kısa kolon	var	1	5

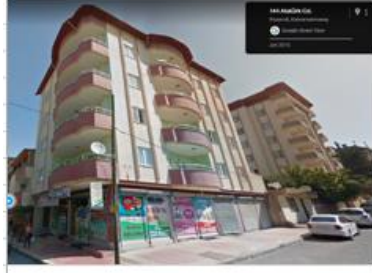
97. YAPI	kat sayısı	5			YSP(BAÇP)	BDP
	deprem sınıfı puanı	1. bölge		60	65	45
	yumuşak kat	var	1	30		
	bina kalitesi	iyi	0	25		
	ağır çıkma	var	1	30		
	yapı nizamı	bitişik	1	15		
	düşeyde düz.	yok	0	15		
	plada düz.	yok	0	10		
	zemin eğimi	yok	0	3		
	kısa kolon	var	1	5

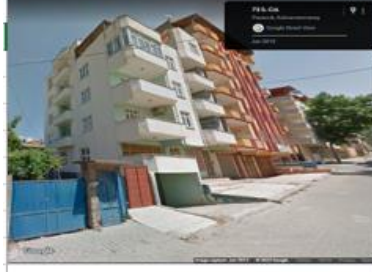
98. YAPI	kat sayısı	5			YSP(BAÇP)	BDP
	deprem sınıfı puanı	1. bölge		60	65	35
	yumuşak kat	var	1	30		
	bina kalitesi	iyi	0	25		
	ağır çıkma	var	1	30		
	yapı nizamı	ayrı	0	10		
	düşeyde düz.	var	1	15		
	plada düz.	var	1	10		
	zemin eğimi	yok	0	3		
	kısa kolon	var	1	5

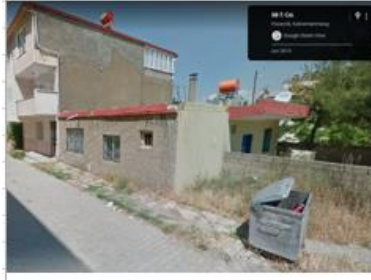
99. YAPI	kat sayısı	1			YSP(BAÇP)	BDP
	deprem sınıfı puanı	1. bölge		90		55
	yumuşak kat	yok	0	10		
	bina kalitesi	kötü	2	10		
	ağır çıkma	yok	0	10		
	yapı nizamı	bitişik	1	10		
	düşeyde düz.	yok	0	5		
	plada düz.	yok	0	5		
	zemin eğimi	yok	0	3		
	kısa kolon	var	1	5

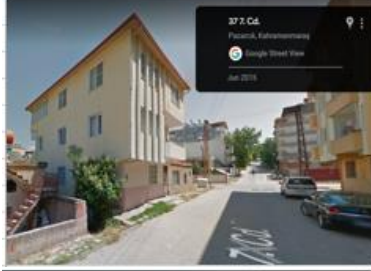
100. YAPI	kat sayısı	3			YSP(BAÇP)	BDP
	deprem sınıfı puanı	1. bölge		80		25
	yumuşak kat	yok	0	20		
	bina kalitesi	iyi	0	10		
	ağır çıkma	var	1	20		
	yapı nizamı	bitişik	1	10		
	düşeyde düz.	var	1	10		
	plada düz.	var	1	10		
	zemin eğimi	yok	0	3		
	kısa kolon	var	1	5

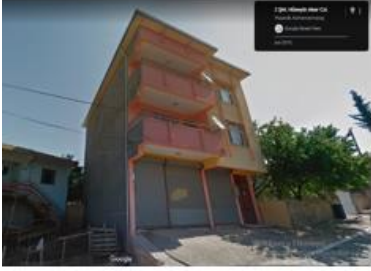
101. YAPI	kat sayısı	3			YSP(BAÇP)	BDP
	deprem sınıfı puanı	1. bölge		80		20
	yumuşak kat	var	1	20		
	bina kalitesi	iyi	0	10		
	ağır çıkma	var	1	20		
	yapı nizamı	bitişik	1	15		
	düşeyde düz.	yok	0	10		
	plada düz.	yok	0	10		
	zemin eğimi	yok	0	3		
	kısa kolon	var	1	5

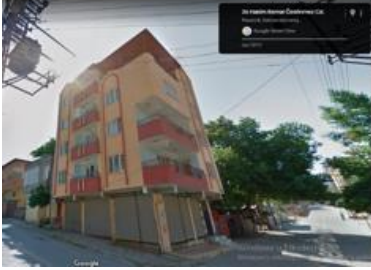
102. YAPI	kat sayısı	5			YSP(BAÇP)	BDP
	deprem sınıfı puanı	1. bölge		60	65	17
	yumuşak kat	var	1	30		
	bina kalitesi	iyi	0	25		
	ağır çıkma	var	1	30		
	yapı nizamı	bitişik	1	15		
	düşeyde düz.	var	1	15		
	plada düz.	var	1	10		
	zemin eğimi	var	1	3		
	kısa kolon	var	1	5
