**April 2020**

**Ali FIRAT**

**EVALUATION OF STRUCTURAL PROBLEMS OF  
GEBEN CASTLE AND RECOMMENDATIONS FOR  
STRUCTURAL SOLUTION**

**M.Sc. THESIS  
IN  
CIVIL ENGINEERING**

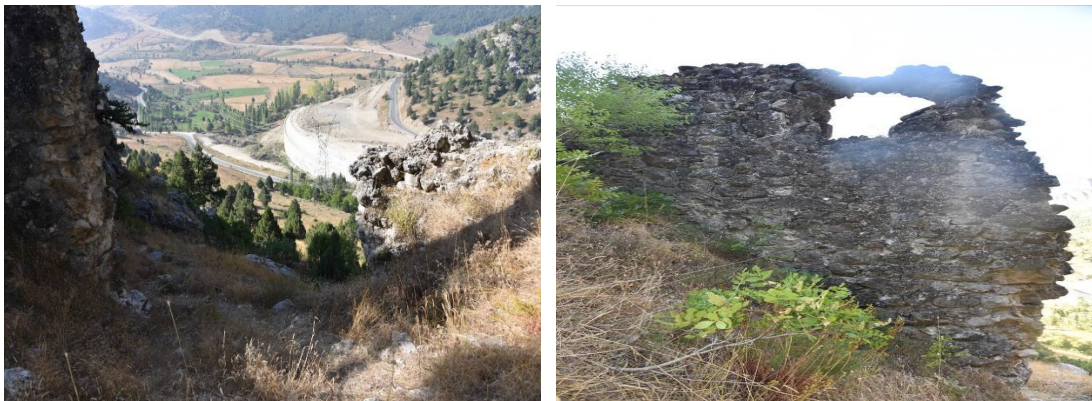
**Figure 3.21:** 1. Courtyard Inner Fortification Walls

1. The courtyard entrance is in this direction and has a width of 1.04m. The GI1 wall to the west of the opening is 4.30x3.60m. in the form of a pile of rubble. The GI2 wall, which is in the eastern direction of the opening, is more robust and is inclined according to the topography of the rocky area. 5.40m in length and 5.80m in height. There is a clearance of 0.66x0.95m close to the square at the height of 6.37m from the base level. The interior, which is covered with bushes and trees, also covers the city

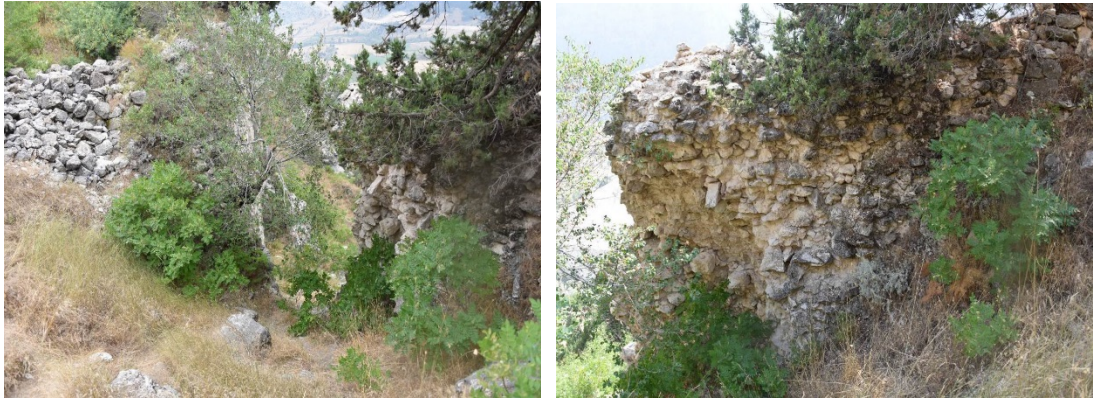
**Figure 3.22:** 2. Courtyard Inner Fortification Walls

The city walls forming the second courtyard started from the east direction and continued uninterrupted by drawing zigzags taking the shape of the rocks and were divided near the center. This part of the entrance to the second courtyard has been severely damaged. There are jamb remains on the wall. The material is in the form of large coarse stone and the inner filling is mortar and rubble filling. The interior, which is covered with bushes and trees, prevents the perception of the ground. The bushes and trees in the interior are covered with walls. Joint discharges, plants, moss, herbaceous and woody plants can be seen on the wall surfaces. Its length is 8.00m and its height is 6.70 meters.

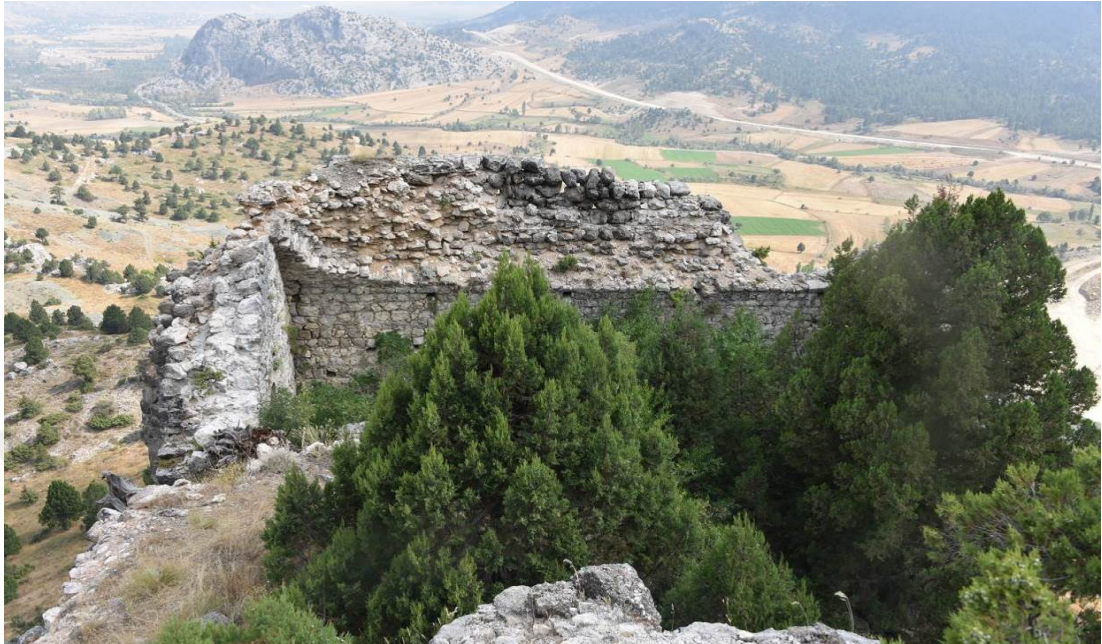
**Figure 3.30:** Structure A Northern Front

North Front; This facade is completely demolished from the upper part, several rows can be perceived from inside the structure and the body walls are standing. The rubble inner wall of the building, which was built with coarse stones, can be seen.

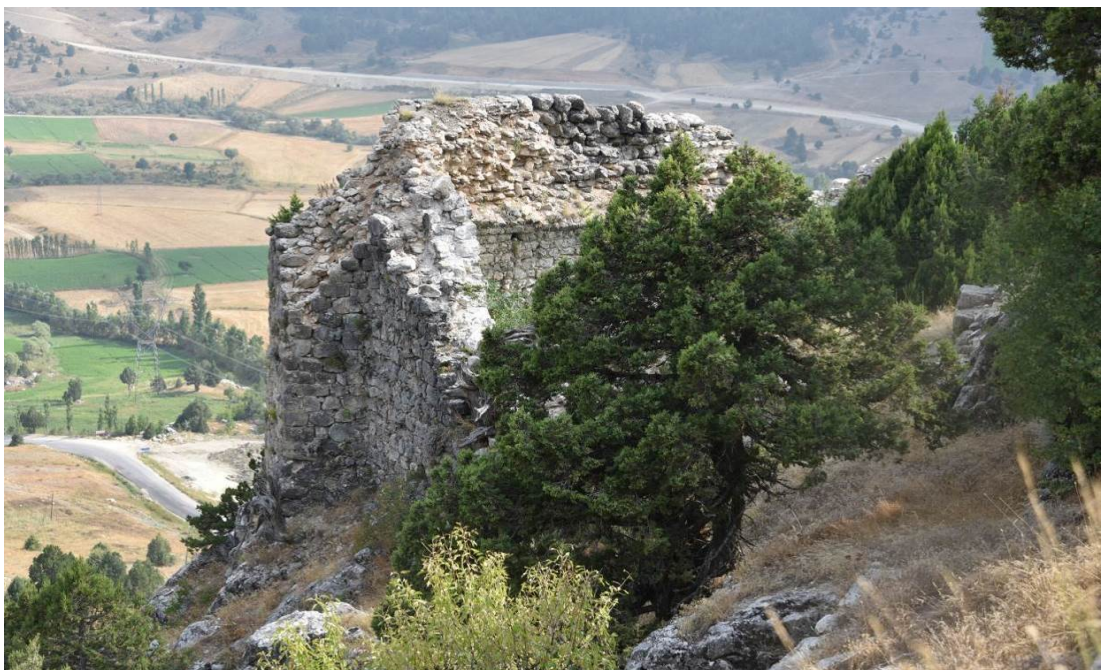
**Figure 3.31:** Structure A Northeast Front

Northeast Front (DD3, A-DD4, A-DD5 Walls); It is shaped according to the topography of the rocky area. Paving blocks which completely destroyed contained in the upper portion of the body wall it is observed that the walls in places decanted.

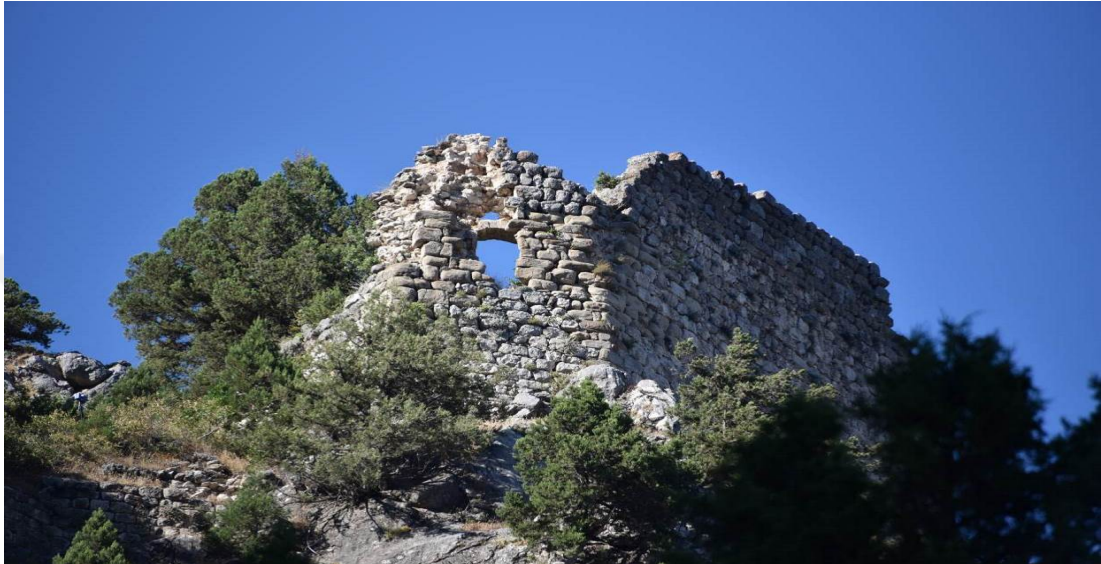
**Figure 3.32:** Structure A Southern Front

Southern Front (A-DD7, A-GD13 Walls); which has been shaped by rocky areas, A-DD7 wall at a height of 12.00 and 14.42. The A-GD13 wall is 9.46m high from the base level. 3.97 the height of the base level and the upper portion of arched openings 0.89x1.44m sizes are available. It is seen that the paving stones are poured and dislocated from the upper and lower part of the opening. Intense vegetation is present on the wall surface.

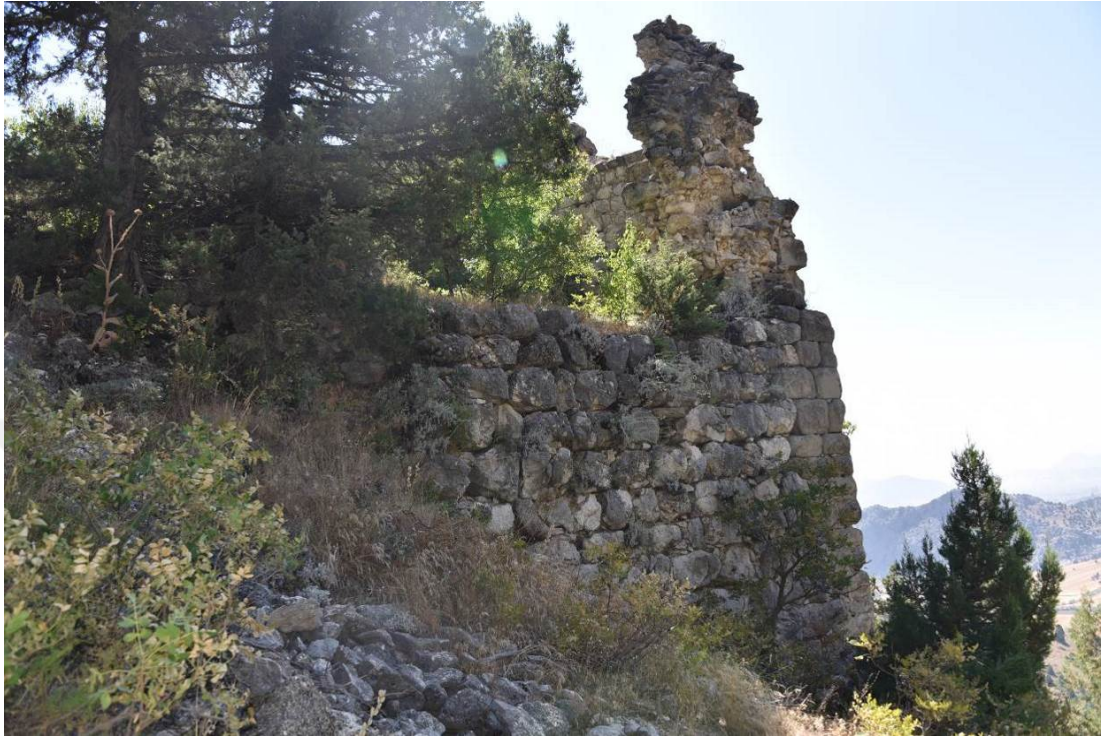
**Figure 3.34:** Structure A Southwest Front

Southwest Front (A-GD14 Wall); The curved wall measures 7.18x5.06 m and is demolished from the upper section. The knitting system is the same as the overall structure.

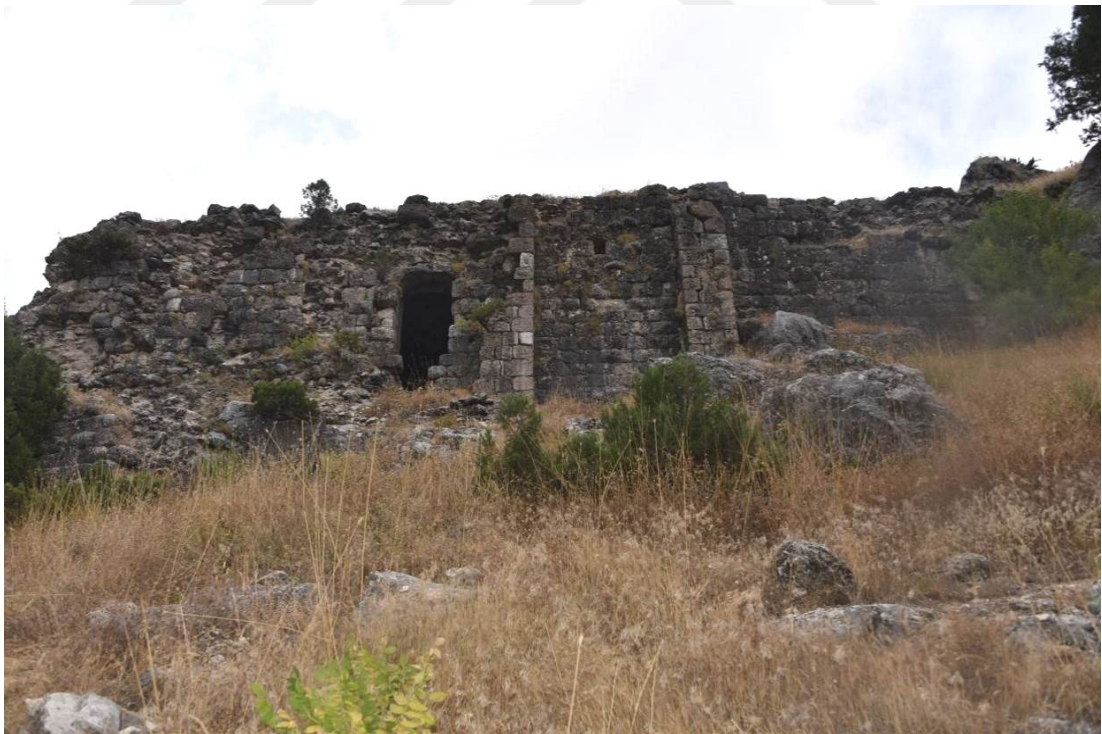
**Figure 3.40:** Structure C South Front

The southern wall of structure C has completely collapsed from the upper section and the remains of the wall, which is gradually overflowing from the wall, can be seen in the north direction of the upper section. It is seen that the paving stones of the southern façade wall have been poured from place to place, and vegetation and microbiological formations can be seen on the wall surface of the structure.

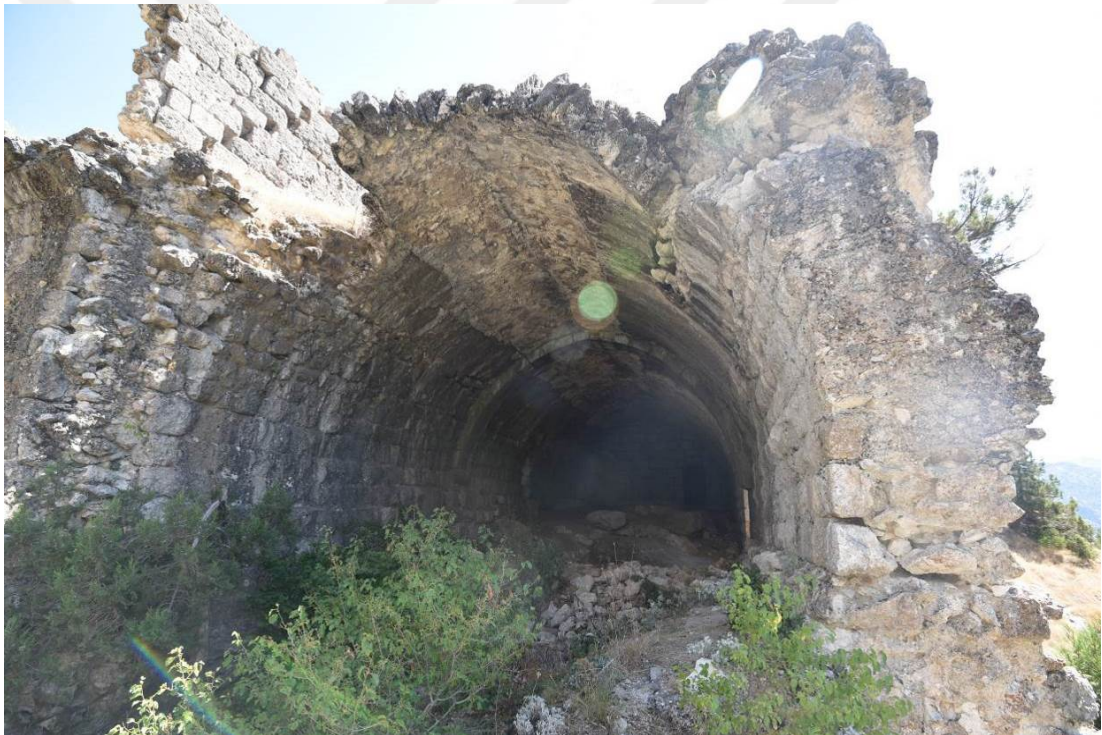
**Figure 3.41:** Structure C Western Front

This façade, which is shaped according to the topography of the rocky area, has a height of 15.40m and a width of 15.00m. There is an opening of 0.19x0.93m in height of 6.73m above the base level of the wall where the BD5 wall and the circular sign of this façade facing room 201 are located. The walls of this facade have been demolished from the upper part, the cladding stones of the walls have been cast and the rubble stone material is seen inside. On the surface of the wall, the stones move to the lower level. Vegetation and microbiological formations are observed. It enters 5.00m inwards from the end of the wall in the western direction and joins with the western walls of the 1s C ”structure. The “C” space in the west has a width of 6.75m and a length of 5.95m. (The wall is completely destroyed in this direction)

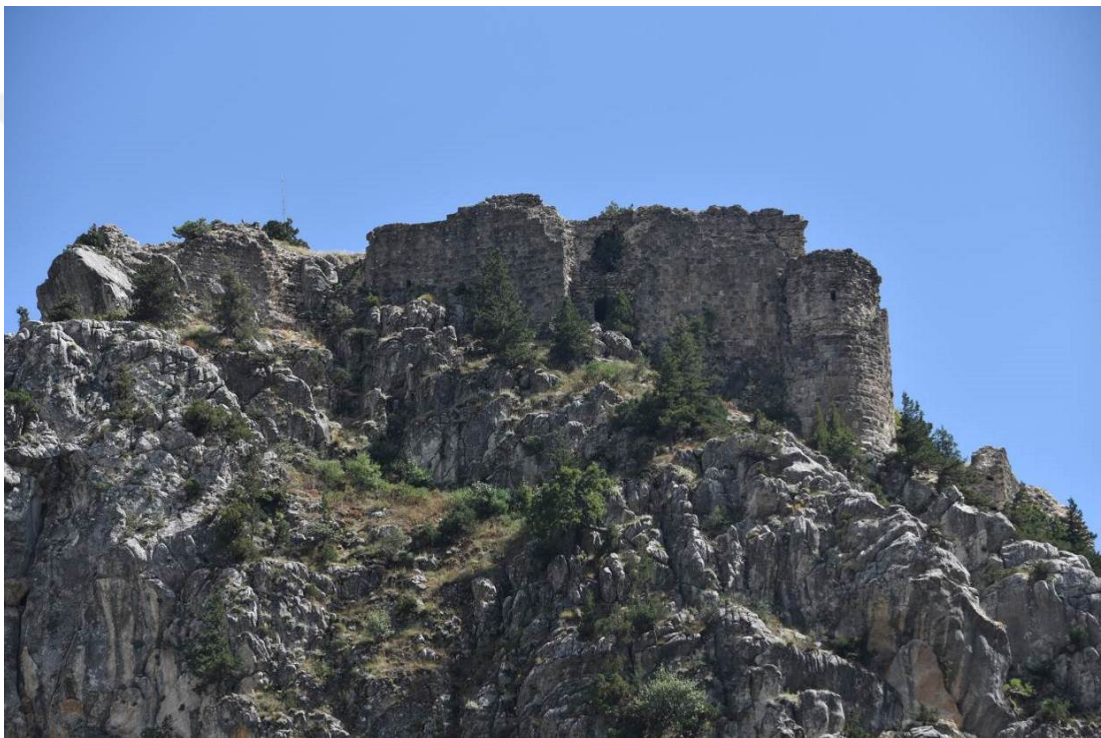
**Figure 3.42:** Structure C North Front

at a height of 2.10m above the foundation level and a second aperture at the top of this aperture 2.50m. The northern façade wall has completely collapsed from the upper part and the cladding stones of the wall have been poured from the upper part. Subsequently, the C-KD4 protrudes towards the 1.81m exterior and continues. The front wall of C-KD5, whose upper part is completely demolished, has a width of 13.84m and a height of 11.35m with an opening of 0.27x0.79m in the foundation level. The wall structure is 5.00 m high and merges with the rock mass. Damages caused by vegetation and microbiological formations can be seen on the entire wall surface where the covering stones are poured.

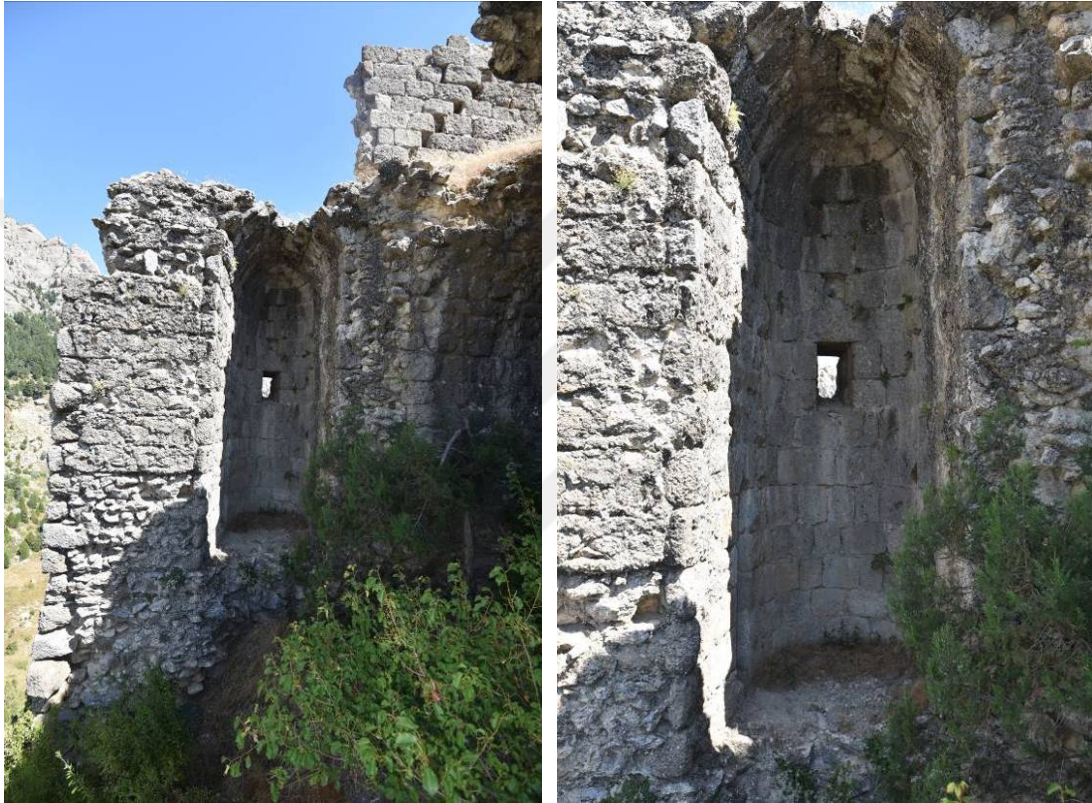
**Figure 3.44:** Structure C Space No. 201 Watchtower

It was built on a rocky ground that protrudes out in this part of the fortress in the north-west direction. Rubble stone inner filling is exposed as the outer covering stones of the connection walls of the room have been poured. As it is understood from the remaining walls of the connecting walls and the cladding stones of the space, mainly rustic stones were used in these parts. Since the interior of the tower and walls are under the rubble

piles, it does not seem possible to get an idea. The semicircular planned space is 6.52m tall and 1.99m wide and 3.97m deep. There is a window opening of 0.45X0.87m in the middle of the northern wall at a height of 3.00m from the foundation level. The cover system of the space is partially demolished. On the western front wall, there is a door opening of the room that cannot be entered. The walls on the southern façade of the room have been demolished and the floor covering is partially demolished and the interior is covered with soil and plants.

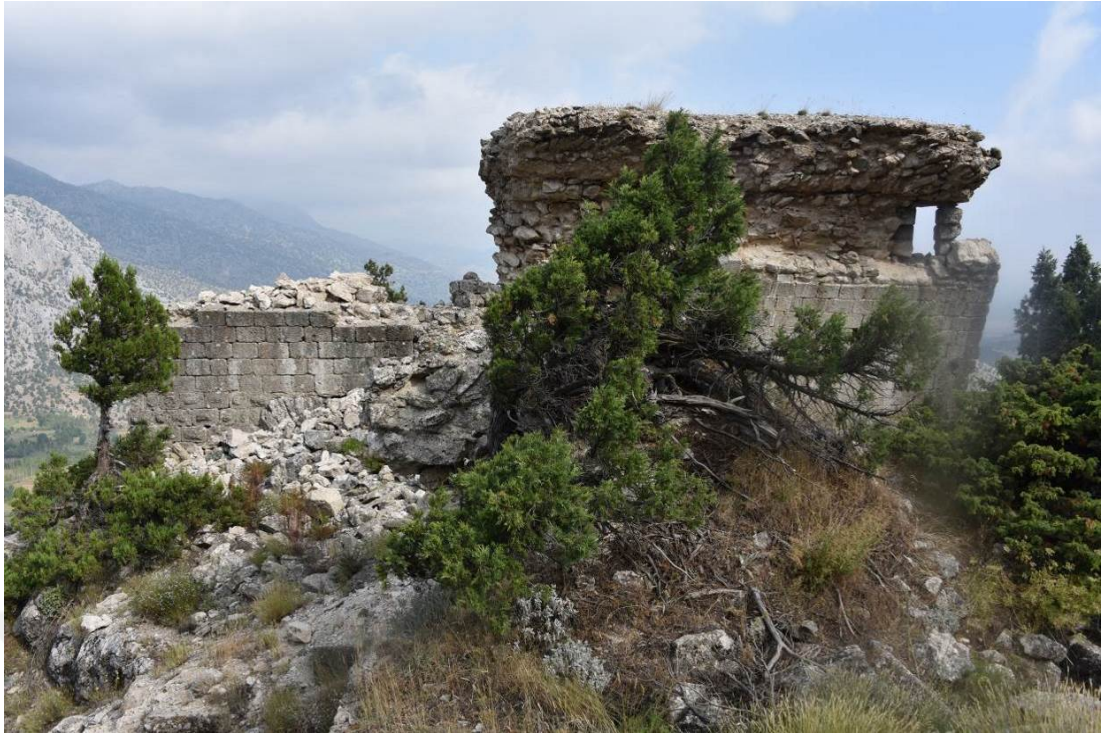
**Figure 3.50:** Structure D Eastern Front

Situated on the rock mass and the walls of varying wall height of 7.54 at between a portion oluşturmaktadır.1.40x4.50m the rock found that wall formed by rocky areas, 1.20 is the thickness of an arched niche in 0.30m.x0.52m measure the south end of the east wall There. The western wall of room 204 is visible from this façade and the rectangular window measuring 0.43X1.15m at the southern end of the wall has been severely damaged. Smooth cut stone work is seen as a knitting system. An important part of the facade wall is demolished.

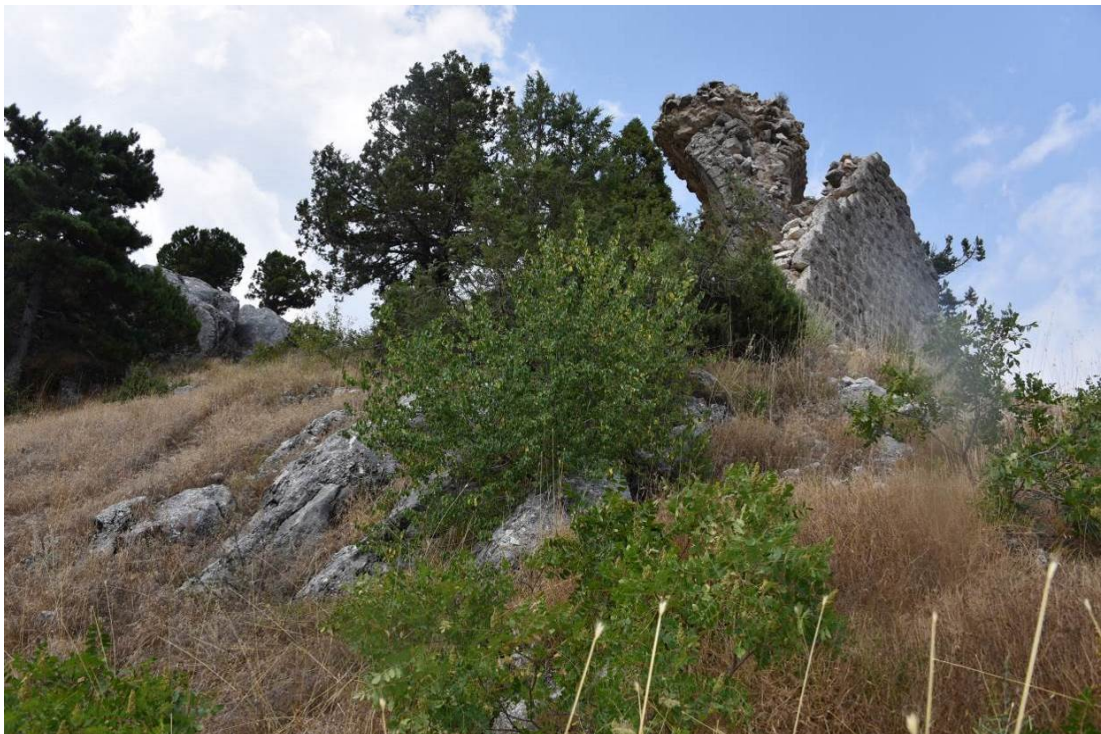
**Figure 3.51:** Structure D South Front

It is completely demolished and remains of 1.71x7.96m wall. It consists of a rocky, bushy and wooded area.

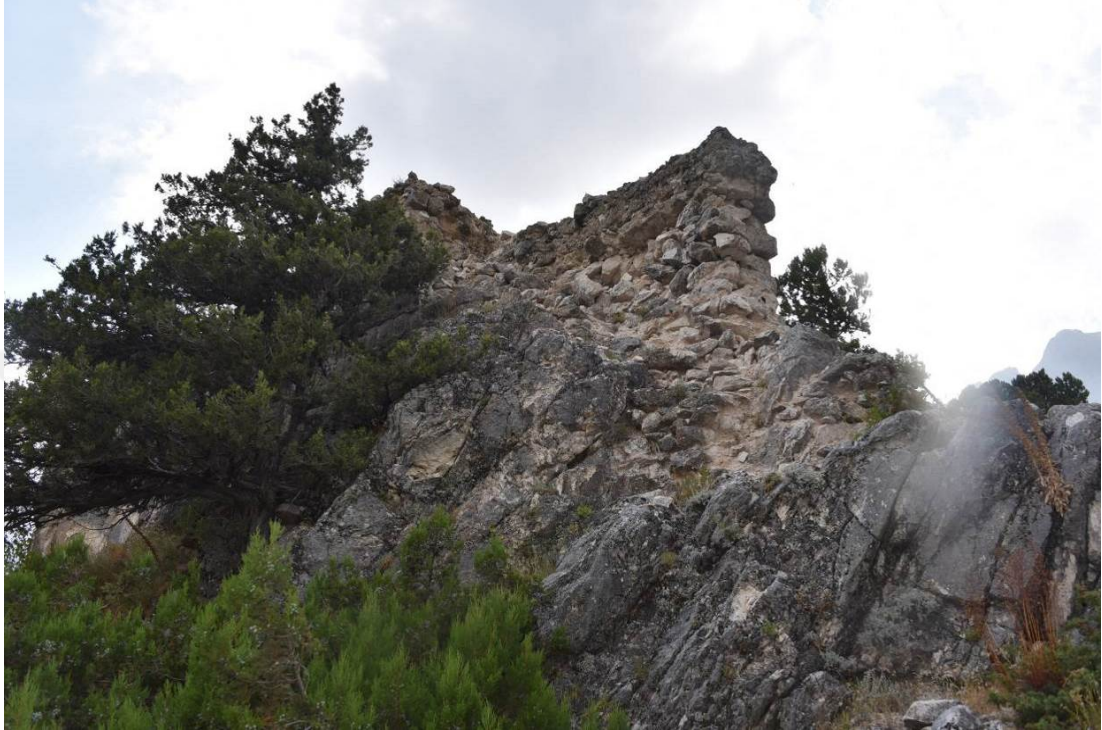
**Figure 3.52:** Structure D North Front

Located on the front of the rock mass is 17.50 in length, in the eastern part of the wall remains the basic measure seviyede3.00x5.71m space 3.46X7.00 204 m in the western part of the northern wall ruins are seen in the dimensions.

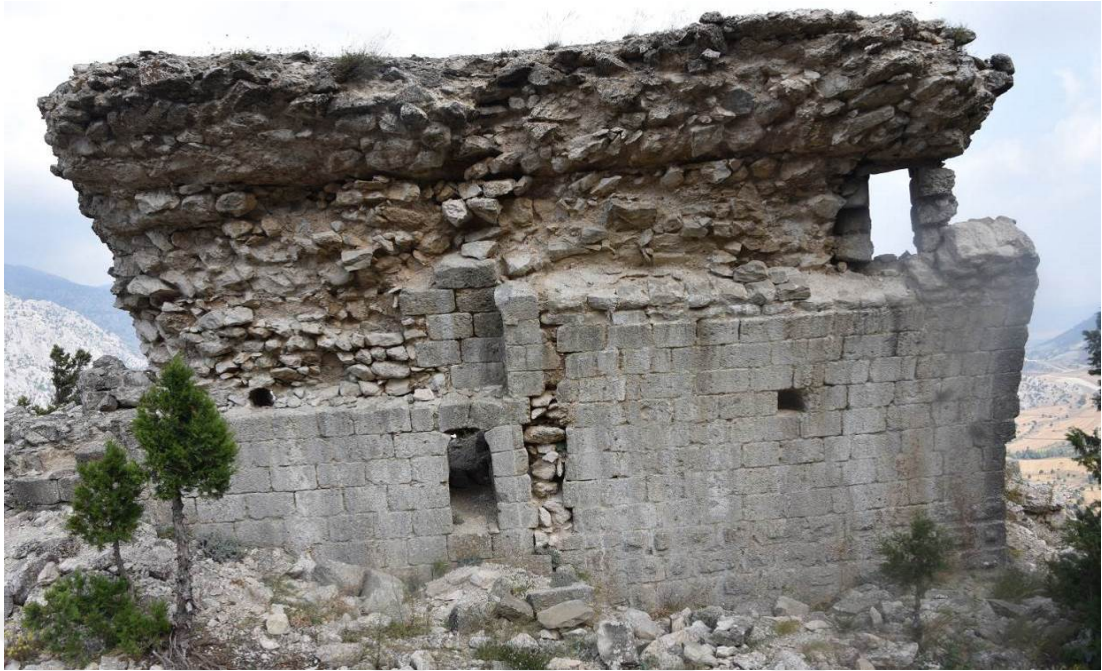
**Figure 3.53:** Structure D Space No. 203

The eastern wall of the room is substantially standing, and the wall in the south direction of the eastern façade has been severely destroyed and measures 15.67X6.20m. In the upper part of the facade, the vault cover has been destroyed. The internal rubble of the wall is seen. 204 on the east façade opening to space 1.17m height0.44m. width and 1.17m. There is an opening in depth. It is observed that the paving stones were poured in the area just south of this opening. On the eastern wall, two square beam holes measuring 0.30X0.30m still exist today. At the southern end of the eastern wall there is another rectangular aperture measuring 0.83X0.98m at a height of 3.82m from the foundation level. Stones and debris from the façade wall have covered the interior. The ground consists of trees and stones.

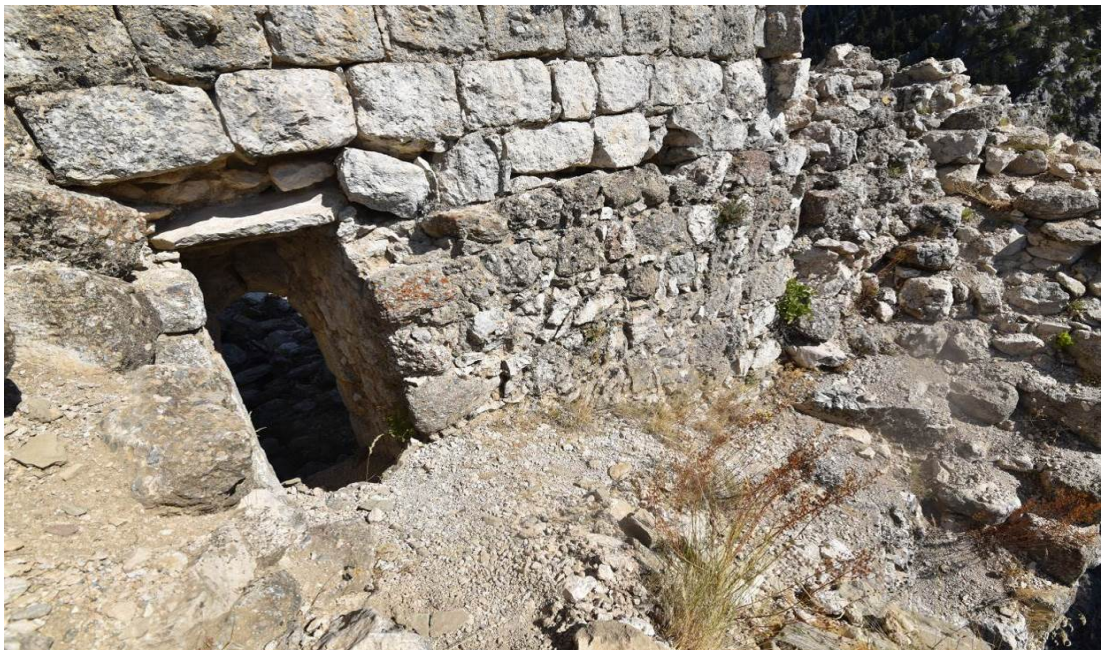
**Figure 3.54:** Structure D Space No. 204

Room 204 is not in proper form. The material is rustic and smooth cut stone. The west wall of this room is the wall of room 203. The interconnected spaces 203 and 204 are interconnected by a round arched opening. The east wall and cover system of room 204 has been demolished and consists of the remains of the city wall. The interior is full of rubble.

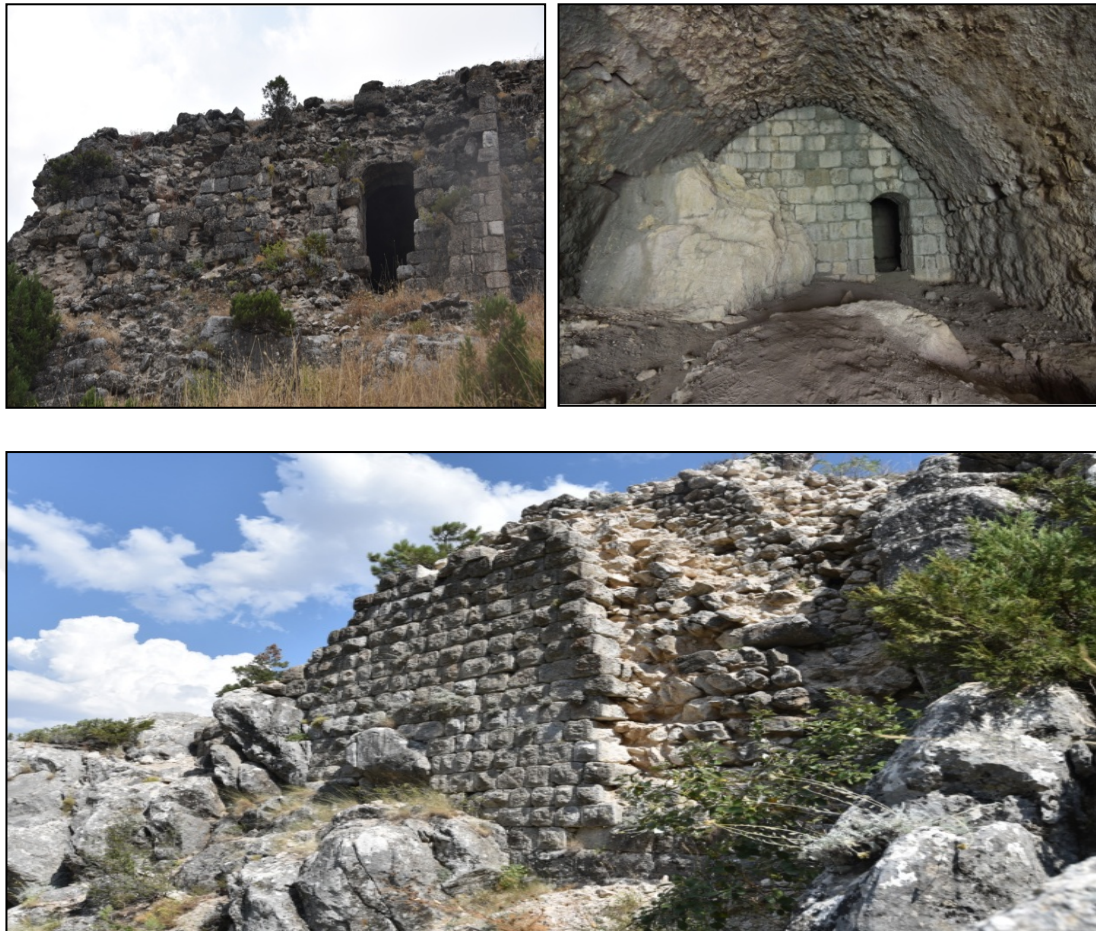
**Figure 4.3:** Structure of C; a) Southern Front rundown buttresses and semi-rundown 3. Strut view b) Main flat vault space. c) Vault Exterior North Facade Wall Losses

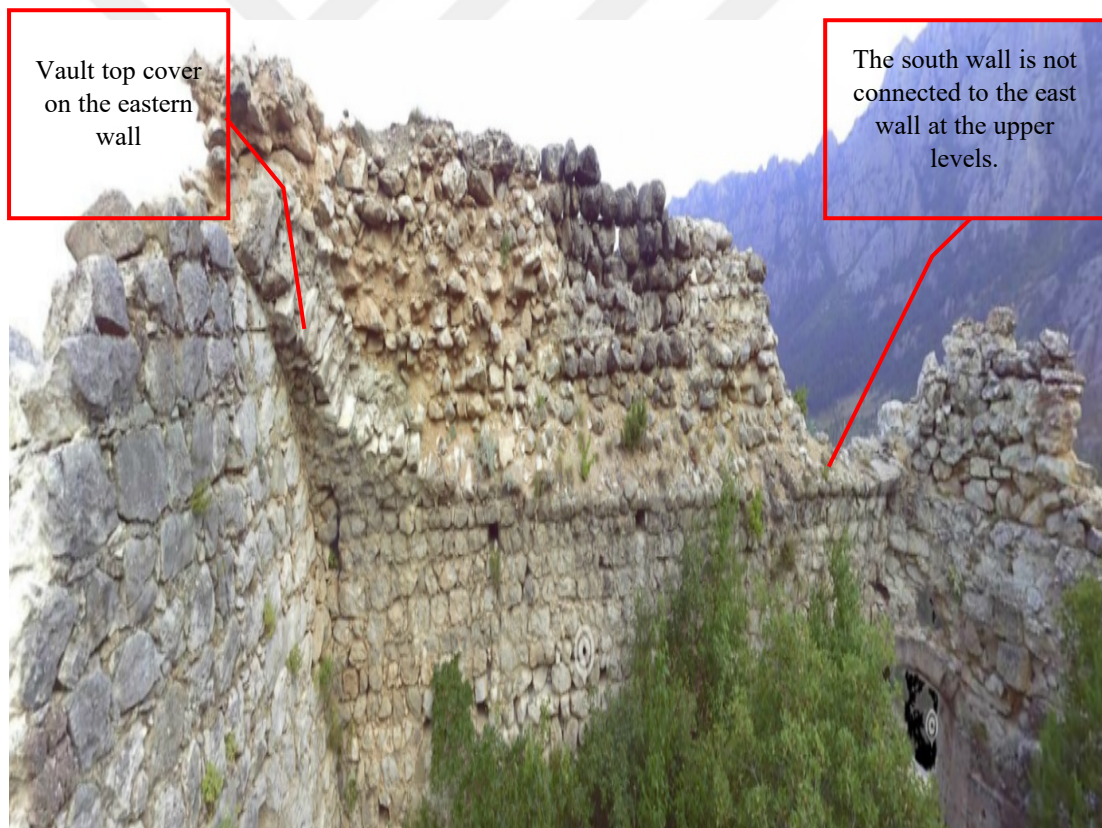
The structures in Geben Castle were subjected to severe local destruction. The building “A miş, which was built on a sloping terrain as in the whole castle, is thought to be a vaulted structure and has a plan close to a rectangle. Currently the northern wall of the building has been completely destroyed and the roof cover has a trace on the eastern side. In the western part of the south wall, it can be said that there is no connection at one end of the south wall, where it collapses up to the vault stirrup line.

**Figure 5.1:** Structure A View of the South Wall from the Interior
