# Cultural Perception Performance Assessment of Adaptively Reused Heritage Buildings: Kilis Eski Hamam Case Study

The case study building was evaluated through a series of walk-throughs, photographs, documentation, and a user survey. The POE has pointed to damage and authenticity loss in the building by reuse based on established conservation principles concerning intangible heritage values and cultural perception, resulting in a series of recommendations to prevent future deterioration and improve the performance of the building. A key observation is that data from the user survey do not coincide with the findings based on internationally acknowledged principles of conservation practice, which indicates that heritage awareness still has not been gained by the wider society. Hence, this study concludes that more research is required to examine the use of POEs in addressing heritage conservation issues and suggests a greater understanding of the role of POE surveys for a more valuable insight into user feedback. It also provides designers and decision-makers with matters to be taken in account regarding the preservation of authenticity when executing an adaptive reuse project for a

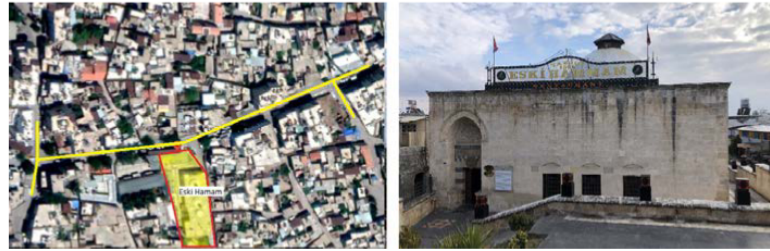
**Figure 1.**  
a) Location of Eski Hamam in Kilis  
b) Northern Façade  
(Photos by first author)

Eski Hamam is a rectangular-shaped building (Fig. 1a) accessible through one main gate on the northern façade (Fig. 1b). The backyard is accessible from the southwest of the surrounding courtyard through a wooden door. The hammam was a "single bath", with men and women having separate bathing times; rather than separate entrances and chambers. The typological characteristics of Eski Hamam can be recognized from the outside, as each main space is in different dimensions in height and width (Fig. 2). The main sections of *soğukluk* (frigidarium), *ılıklık* (tepidarium), and *sıcaklık* (caldarium) are linearly lined up from north to south. Each space is identified in fig. 3: The entrance, *taşlık* (1), leads to the *soğukluk* (2) with the central fountain, the *ılıklık* (4) with the *aralık* (3) that includes the toilet, the *sıcaklık* (5), the furnace, and the water tank (6, 7).

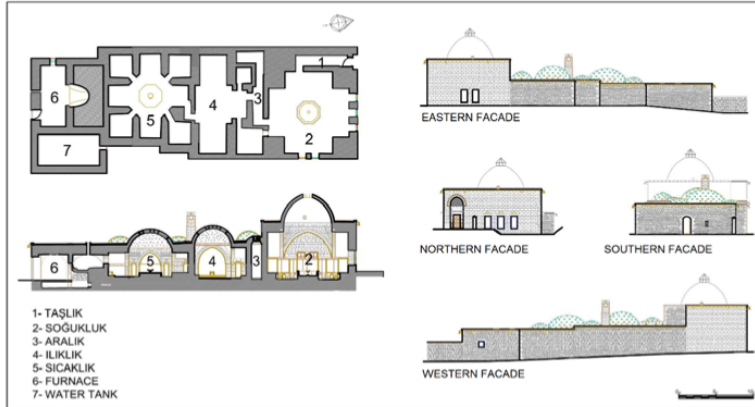
**Figure 2.** The architectural survey of the Eski Hamam. Plan, section, and elevations. (Source: Bebekoglu, 2005)

The *soğukluk* is a square-shaped and domed chamber. Equipped on each side with benches and niches arranged around a central fountain, its setting aimed to maintain the centrality of the compositional forming of the space. The *ılıklık* is the medium-temperature room, directly connected with the toilet and the *mikveh* (bath used for ritual immersion in Judaism). The *sıcaklık*, the heart of the *hammam*, is connected to the

water tank and the furnace, with smaller rooms for the steam bath (the *halvets*) located over it. There is an octagonal-shaped platform where customers could lie down to relax or get a massage, called *göbektası*, at the centre of the *sıcaklık*.

The hammam structure is ashlar masonry. Its internal and external walls were built with matching ashlar blocks of 25-30 cm. The building interior and the façades are remarkably plain; the main gate on the northern façade is the only decorated element. Eski Hamam was, and still is, situated in a central area of Kilis surrounded by mosques and near a synagogue and a marketplace, so it serviced a great number of locals, both men and women; which suggests that it is a significant element of the city's collective memory.

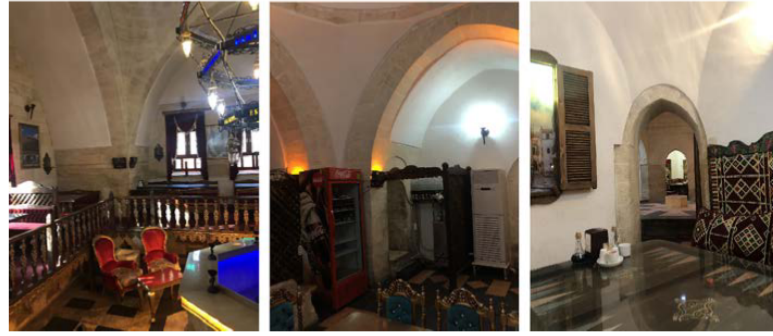
**Figure 3.**

The interior design, finishings and furniture play a crucial role in the perception of space (Altan, 2015). Rugs, carpets, seating elements, decorative objects, and many other random items of various colours dispersedly placed in the Eski Hamam have created a gaudy environment lacking identity and authenticity. In the small chambers (*halvets*) of

sıcaklık, for instance, the dark furniture at varying heights made the spaces cumbersome (Fig. 3).

- a) Sıcaklık
  - b) Ilıklık
  - c) A private room of soğukluk
- (Source: by the first author, 2020)

The variances of colour and form that disrupt the aesthetic integrity indicate that a thorough intangible values analysis was not undertaken pre-refurbishment. The authentic atmosphere of the Eski Hamam was damaged by the adaptation process; the original characteristics of the walls, ceilings, and floors can be vaguely noticed due to poor design decisions and applications.

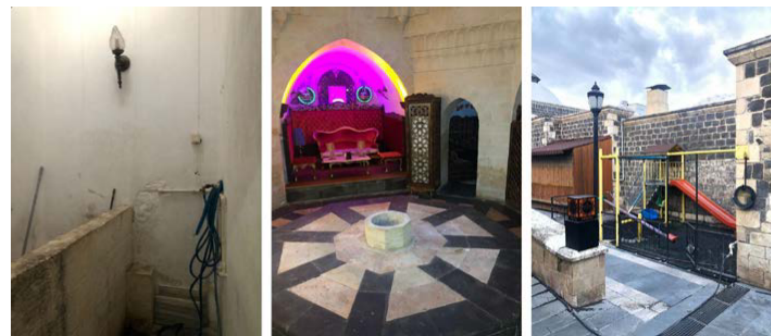
**Figure 4.**

- Mikveh
- Sıcaklık
- Western Façade

- not using the *mikveh* as storage, since it was used for the religious bathing rituals of the Jewish community (Figure 4a)
- representing information about the hammam and local hammam culture in the building and its vicinity
- removal of all coloured lighting in the interior and exterior of the building and handing the lighting design over to lighting specialists
- renewal and reorganization of inappropriate fittings and furniture in all spaces (Figure 4b)
- removal of the large name sign installed on the roof of the building as it is incompatible with the building in terms of size and aesthetics
- removal of the children's playground attached to the western wall of the building (Figure 4c)
- using techniques and materials only known to be technically and aesthetically compatible with the building fabric.
