**ANALYTICAL EVALUATION OF SELECTED CONCRETE
STRUCTURES AGAINST EARTHQUAKES IN TURKEY**

**M.Sc. THESIS IN
CIVIL ENGINEERING**

FERİDE CEYLAN

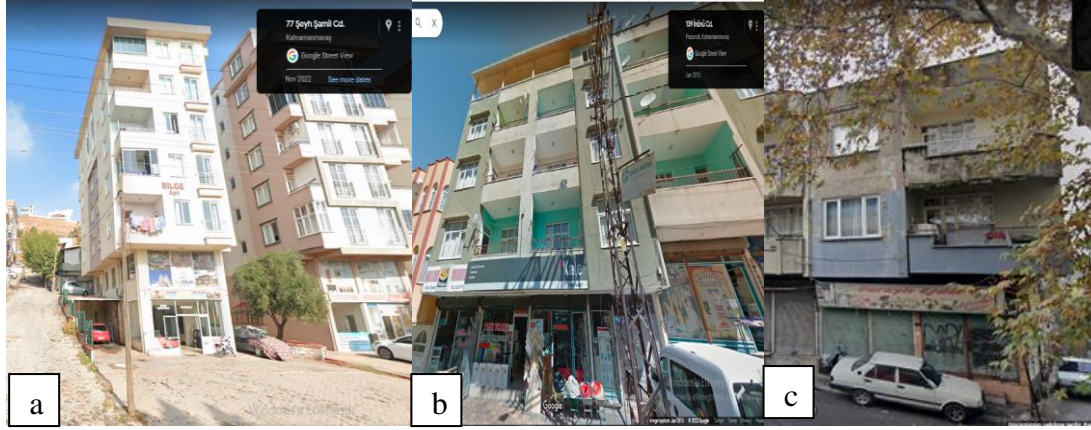
Figure 5. 3: good quality building b) Medium quality building c) Poor quality building

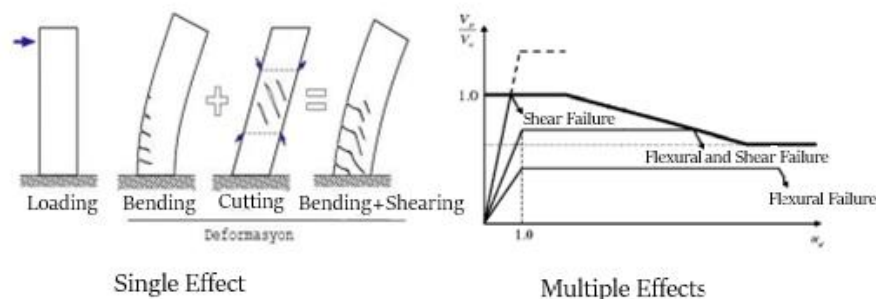
If the shear force, axial force and moment acting on reinforced concrete columns are more than the bearing capacity of the column, damage occurs in the column, which is the carrier element. Damage is seen in the column due to the inclined shear cracks being 45 degrees in the column, the formation of gaps due to the inability of the concrete to settle due to the dense longitudinal reinforcement in the column, the lack of strength of the concrete compressive strength between the concrete and the reinforcement, and the insufficient carrying capacity of the shear force in the column [23]. The formation of 45-degree shear cracks is due to the fact that the stirrup is not sufficient in the area where the junction areas of the column are located and the reinforcement sprout lengths are not paid attention to. Oblique shear cracks that occur in case of stirrup insufficiency also cause brittle fracture of the concrete [24]. In cases where concrete and reinforcement do not work together, the reinforcements are separated from the concrete when they do not reach the yield stress. The event that causes them to collapse suddenly occurs due to the crushing and cracking of the concrete before the longitudinal reinforcement of the column reaches the flow level. In this case, concrete pressure fracture damage occurs if the concrete compressive strength of the column or the excessive axial load of the column is very low. [23]

Figure 5. 7: Single and multiple impact injuries in columns

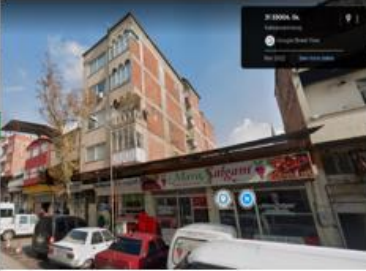
1. YAPI	kat sayısı	5			YSP(BAÇP)	BDP	
		deprem sınıfı puanı	2.bölge	80			0	45
		yumuşak kat	yok	0	30			
		bina kalitesi	iyi	0	25			
		ağır çıkma	var	1	30			
		yapı nizamı	ayrı	0	1			
		düşeyde düz.	yok	0	15			
		plada düz.	yok	0	10			
		zemin eğimi	yok	0	3			
kısa kolon	var	1	5

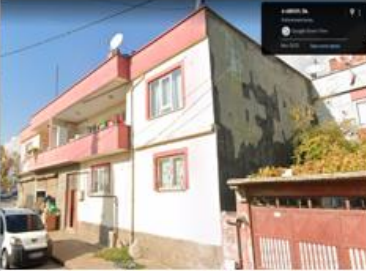
2. YAPI	kat sayısı	5			YSP(BAÇP)	BDP	
		deprem sınıfı puanı	2. bölge	80			65	70
		yumuşak kat	var	1	30			
		bina kalitesi	orta	1	25			
		ağır çıkma	var	1	10			
		yapı nizamı	bitişik	1	5			
		düşeyde düz.	yok	0	15			
		plada düz.	yok	0	10			
		zemin eğimi	yok	0	3			
kısa kolon	var	1	5

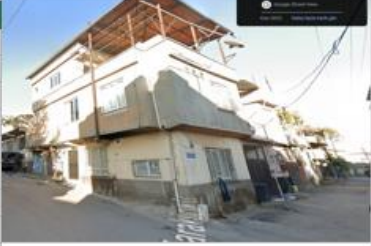
37. YAPI	kat sayısı	4			YSP(BAÇP)	BDP
		deprem sınıfı puanı	2. bölge		90		30
		yumuşak kat	yok	0	30		
		bina kalitesi	orta	1	15		
		ağır çıkma	yok	0	30		
		yapı nizamı	bitişik	1	15		
		düşeyde düz.	var	1	15		
		plada düz.	var	1	10		
		zemin eğimi	yok	0	3		
kısa kolon	var	1	5

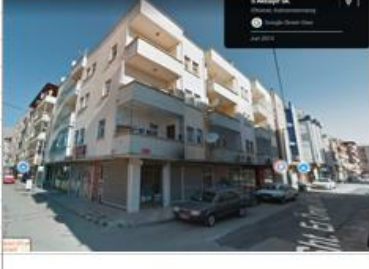
44. YAPI	kat sayısı	5			YSP(BAÇP)	BDP	
		deprem sınıfı puanı	2. bölge		80	55	35	
		yumuşak kat	var	1	30			
		bina kalitesi	orta	1	25			
		ağır çıkma	var	1	30			
		yapı nizamı	bitişik	1	10			
		düşeyde düz.	yok	0	15			
		plada düz.	yok	0	10			
		zemin eğimi	yok	0	3			
		kısa kolon	var	1	5

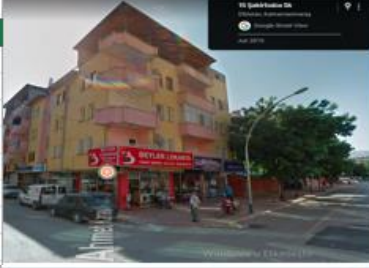
45. YAPI	kat sayısı	4			YSP(BAÇP)	BDP	
		deprem sınıfı puanı	2. bölge		90	75	75	
		yumuşak kat	var	1	30			
		bina kalitesi	orta	1	15			
		ağır çıkma	var	1	30			
		yapı nizamı	bitişik	1	10			
		düşeyde düz.	yok	0	15			
		plada düz.	yok	0	10			
		zemin eğimi	yok	0	3			
		kısa kolon	var	1	5

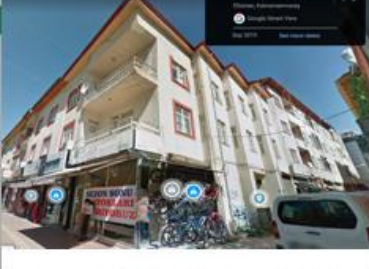
46. YAPI	kat sayısı	5			YSP(BAÇP)	BDP

deprem sınıfı puanı	2. bölge		80	65	20	
		yumuşak kat	var	1	30			
		bina kalitesi	orta	1	25			
		ağır çıkma	var	1	30			
		yapı nizamı	bitişik	1	10			
		düşeyde düz.	var	1	15			
		plada düz.	var	1	10			
		zemin eğimi	yok	0	3			
		kısa kolon	var	1	5

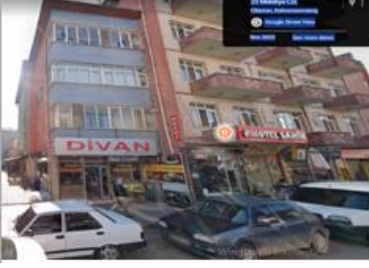
47. YAPI	kat sayısı	3			YSP(BAÇP)	BDP	
		deprem sınıfı puanı	2. bölge		100		15	
		yumuşak kat	var	1	20			
		bina kalitesi	orta	1	10			
		ağır çıkma	var	1	20			
		yapı nizamı	bitişik	1	10			
		düşeyde düz.	var	1	10			
		plada düz.	var	1	10			
		zemin eğimi	yok	0	3			
		kısa kolon	var	1	5
