**April 2020**

**Ali FIRAT**

**EVALUATION OF STRUCTURAL PROBLEMS OF  
GEBEN CASTLE AND RECOMMENDATIONS FOR  
STRUCTURAL SOLUTION**

**M.Sc. THESIS  
IN  
CIVIL ENGINEERING**

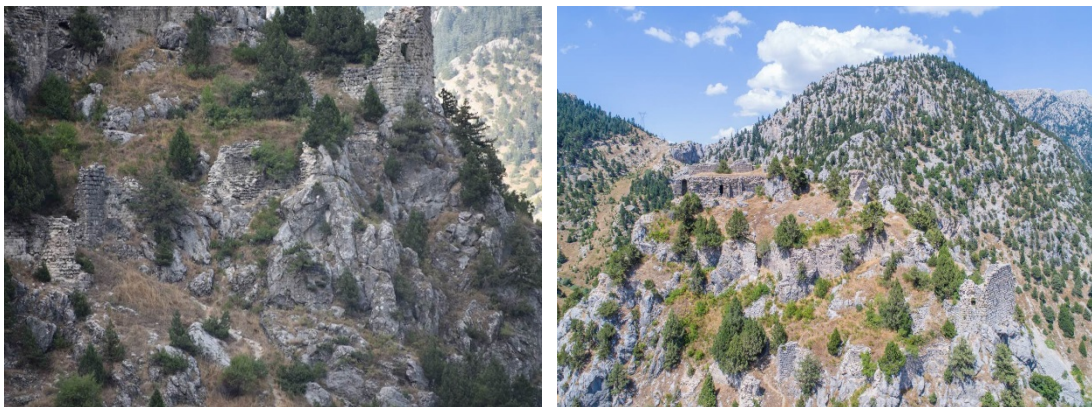
**Figure 3.19:** 1. Courtyard Inner Fortification Walls -1

In the south direction, 94m long city walls are completely demolished from the base level and from the top and are shaped according to the topography of the land.

The GD1 wall is 8.43m long and the highest wall is 4.70m. The wall of GD1 has been demolished from the east and the upper part and the upper part is full of rubble. In addition to the internal rubble filling, a small portion of the wall covering stones remained. The connection wall between the GD1 and GD2, which is 18m long, has not survived. The GD2 wall can be traced at two levels of foundation. It continues unevenly to take the form of rocks. At the end point of the GD2 wall, the wall is connected to the GD4 wall in the form of an arc. The semicircular part forms the GD3 wall. The GD3 wall is largely demolished and can be traced at the foundation level. Today, a tree rises where the wall remains. The wall is flooded to the outside. The GD4 fortification wall, which is located between two circular outward floods, is 11.25m long and 4.77m high. The wall lattice system is made of chest wall technique and the outer side is covered with rustic stones while the inner filling is mortar and rubble.

2.54x6.27m were poured to a great extent, the wall fill of this section was exposed. The GD11 wall is 7.87m long and 6.70m high. This wall, which is covered with trees and plants, is largely demolished and constructed with rough stone. The GD12 wall is shaped on a rocky ground and measures 4.85x2.20m. A significant part of the wall has been demolished and there is extensive vegetation on the surface of the wall. The GD12 wall joins with the rock mass in the east direction and the “A” structure can be reached after a continuation of 1.90m.

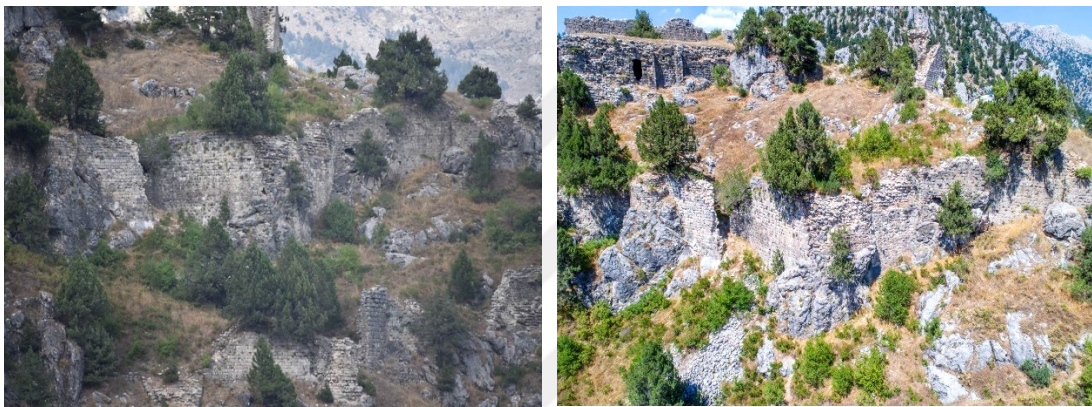
**Figure 3.20:** 1. Courtyard Inner Fortification Walls -2

The city walls forming the second courtyard (inner castle) started from the GD15 fortification wall and continued uninterrupted by drawing the shape of the rocks and continued uninterruptedly by a 1.90 m long opening.

The GD20 fortification wall is integrated with the rock mass in the east direction and has been demolished from the upper part. On the surface of the wall, it is observed that the pavement stones move from place to place. Plants and mosses are seen on the wall surface. The wall measures 4.30x6.80 meters.

The wall structure continues straight after breaking. The GD23 fortification wall is 5.30m high and 5.05m long. Outwardly flooded, in accordance with the rock structure of 9.73m height and 12.30m length of the wall joins the GD24. Moss and vegetation can be seen on the wall surface which is in good condition.

The GD25 wall is 4.98m high and 2.18m long. A small part of the wall, which was gradually demolished in the west direction, has survived. Coarse stone and rustic forum stones were used together as cladding.

The GD27 Wall runs symmetrically towards the south. The GD28 wall, which is located next, is 2.57m. width and 3.27 m high, the cladding stones of the wall were poured from place to place and the city wall was completely demolished from the upper part. Coarse stone and rustic forum stones were used together as cladding. The inner filling is in the form of mortar and rubble filling. Small coarse stones were used on the inner side of the wall.

Further, the GD29 wall, which runs in the northwest direction, continues slightly above the foundation level towards the rocks and the destruction in these parts is significant. The length of the walls is 11.00m and the highest part is 7.50m. The wall was built with large coarse stones and rustic stones. On the surface of the wall, vegetation and moss can be seen.

The GD30 wall, which is 10.40m in length, continues on a rocky ground at an altitude of 2.90m. This section has been severely damaged.

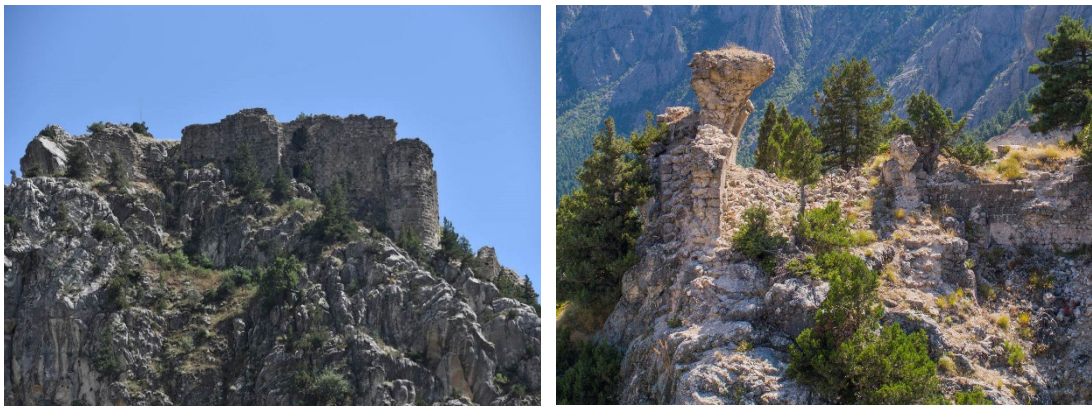
**Figure 3.24:** 2. Courtyard Exterior Fortification walls

As seen throughout the fortress, the gaps between the rocky areas were also closed here. The walls of the walls, which are observed to continue on the rock structure, are shaped according to the topography of the rocky area. Today, most of the city wall is collapsed. The remains of the walls are compatible with the general architecture of the castle. The KD1 wall is 6.00 m long and has survived to the present day as a pile of debris.

The section C-KD2, which is located in the continuation of the wall of KD1, was built with rustic stone masonry and has a circular plan of approximately 3.50m in diameter and 13.36m in height. From the base level up to 7.50m outer cladding stones are strong and after this height 5.85m outer cladding stones poured rubble stone fillings can be seen. At the same time the level of 9.65 0.30x0.65m on the wall. It is located in a rectangle measuring aperture.

In the continuation of the circular section, the C-KD3 building wall is 15.12m high and 13.72m width, the wall structure is completely demolished in the upper part, and cracks and paving stones are seen on the wall surface. To the east of the wall is an aperture of 1.12m in width and 1.70m in height. This opening continues 2.35m towards the interior. Above this opening there is a 2.45 m wall and above it there is an opening whose form and dimensions cannot be determined.

The C-KD5 continues on the rock wall of the building wall. The wall is 13.62m wide and 10.20m high. This section, partially collapsed from the upper section, has a clearance of 0.26x0.78m at the foundation level to the east. The surface of the wall where the covering stones are poured in places and cracks are seen is compatible with the other parts.

The wall of KD7 was built by using natural rocks on the rocky hill which is 8.79m wide and 6.97m high in the rocky area and the east wall gradually collapsed. We see that the rubble stone fill was exposed. The material used is rustic and smooth cut stone.

Between the walls of KD8 and KD9 6.70m. The opening is located. The wall structure, which is 6.84 m high and 1.57 m wide, is the northern façade of the D structure. We see that the completely filled rubble stone fill of the paving stones is exposed.

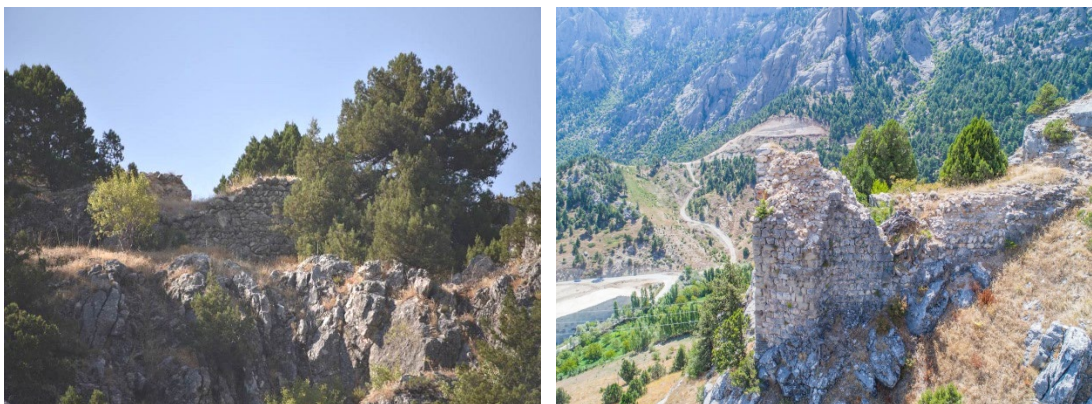
**Figure 3.26:** 2. Courtyard Exterior Fortification walls

DD1, which is positioned according to the shape of the rock mass, is 9.86m wide and 5.10m long. In the northern part of the wall, it was built with cut stone and continued

The DD5 city wall takes the shape of the rocky area outward and protrudes 1.84m. The material is compatible with the overall structure. The DD6 wall is 3.17m wide and 7.88m high. This section, which has been completely destroyed from the upper section, is one of the northeast walls of Structure A. The wall was built with large stones. There are vegetation and microbiological formation on the wall surface.

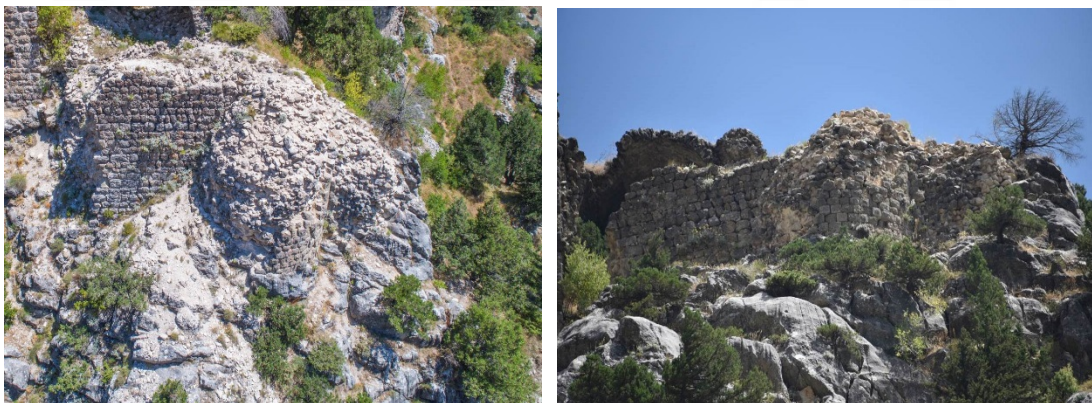
**Figure 3.28:** 2. Courtyard Exterior Fortification walls

This section, which starts with the BD1 wall, is located on the rock mass in the northwest direction following the GD1 wall. Since the outer covering stones of the connecting walls of the fortification wall were poured, rubble stone interior filling was exposed. The wall BD1 is independently located in the northwest.

At the point where the wall BD2 ends, the wall is connected to the wall BD4 in the form of an arc. This arc-shaped outgrowth portion forms the wall BD3. Since the outer cladding stones of the connection walls of this section, which has a radius of 5.28m, have been poured, the rubble stone filling has been exposed. As it is understood from the remains of the connecting stones and the cladding stones of the BD3 wall, mainly rustic stones were used in these parts. The interior of the wall is full of rubble.

The BD3 wall is located next to the BD4 wall. This section, which has a height of 8.25m with a width of 6.15m, is seen to have completely collapsed and filled with debris. Rustic stones were used mainly on the wall surface. On the surface of the wall, plants and microbiological formations are observed.

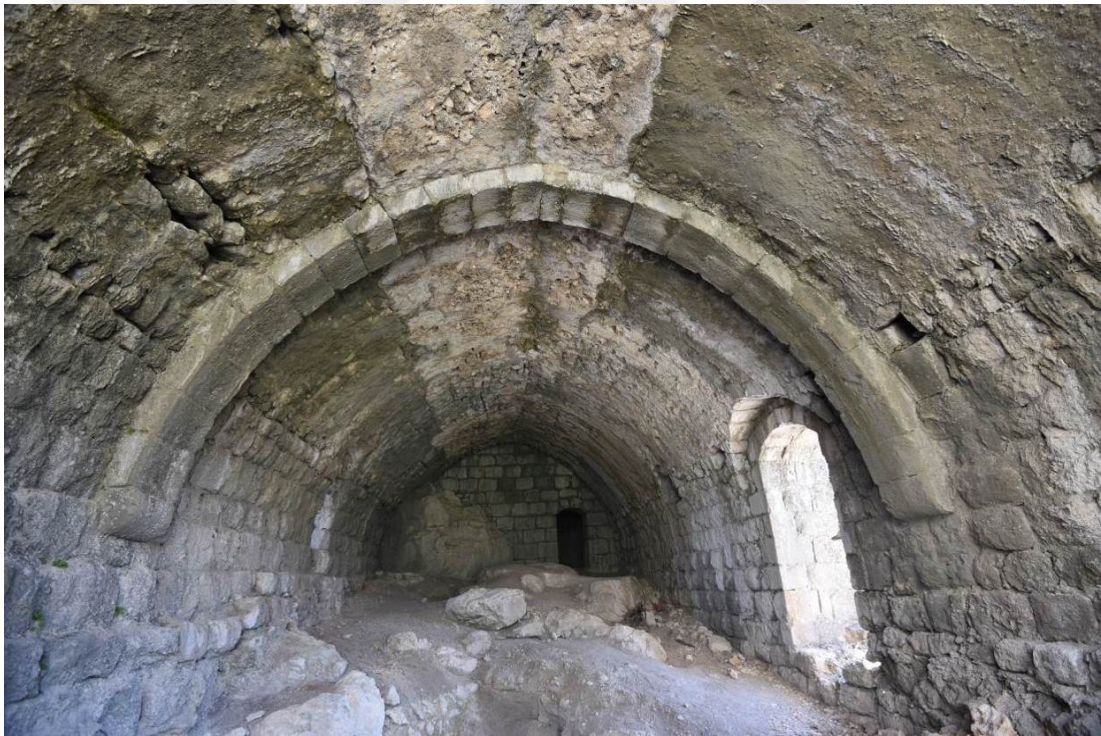
**Figure 3.43:** Structure C Space No. 201

The interior of room 201, measuring 6.94mx20.87m with a rectangular plan, was built in accordance with the topography. At the eastern end of the room, monolithic protrusions were included in the thickness of the wall. Only a small amount of surface areas of exposed rocks are left in their natural form. The other parts were shaved. This room is covered with a pointed vault. Since the interior is quite long, the vault cover was supported by a round arch at a point close to the middle. The support belt resting on the consoles is 6.52m wide and built with smooth cut stone. The entire vault is plastered. At the expansion level of the vault, square slots are still selectable. They

probably support the transverse beams in the center; The only opening in the north wall of room 101 is a wide round arched door. The floor of the door is approximately 1.00 m. It is high. Door on the south wall Another opening near the square measuring 0.40X0.60m at an altitude of 2.50m from the foundation level is observed in the western direction. East direction; 2.50 m in height 0.40 m in width and 0.50 m in length are seen in another opening. At the eastern end of the room 101 there is a round arched door leading to room 202. The door measuring 0.99mx2.05mx0.98m was constructed with smooth cut stone material. The building was built with large coarse type masonry. The vault at the western end of the space and the western wall were destroyed. There is an aperture of 0.90x0.64m facing the “B” section of this section seen at the foundation level. The eastern part of these rooms ends on solid rocks. Under the ground, there are remains of a building which is thought to belong to another building.

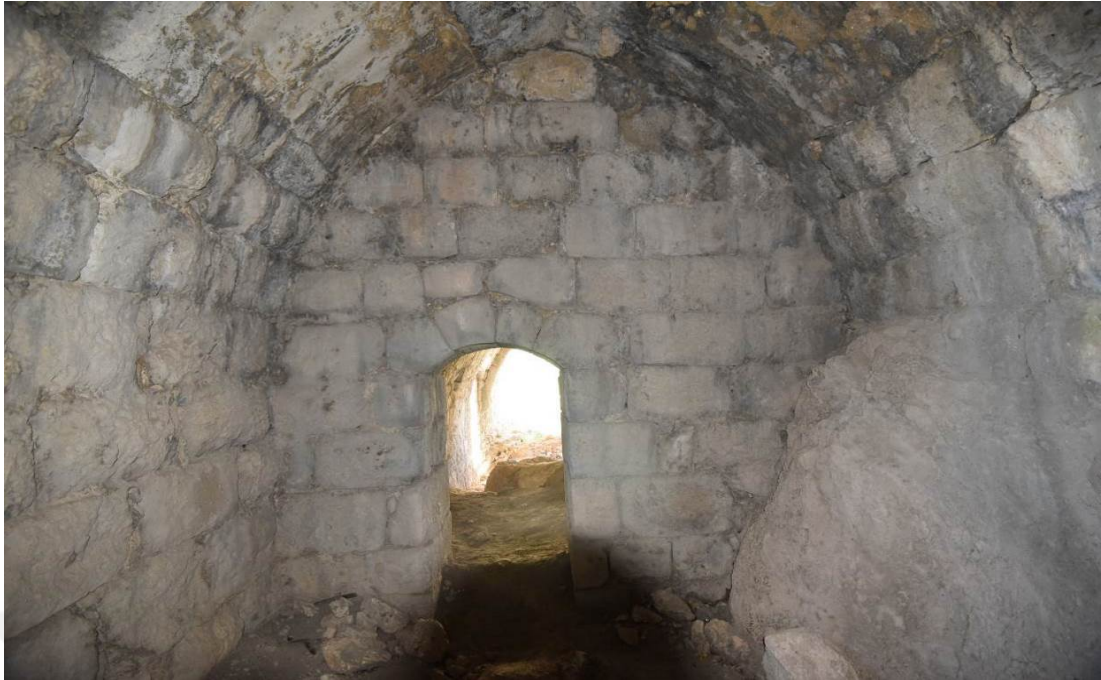
**Figure 3.45:** Structure C Space No. 202

At the eastern end of the rectangular room 201, there is a round arched door that provides access to room 202. The door measuring 0.99mx2.05mx0.98m was constructed with smooth cut stone material. In addition, the only opening of room 202 is a small rectangular window measuring 0.36mx0.85mx1.44m on the south wall. The northwest corner of this small pointed vaulted room is full of natural rock fragments.

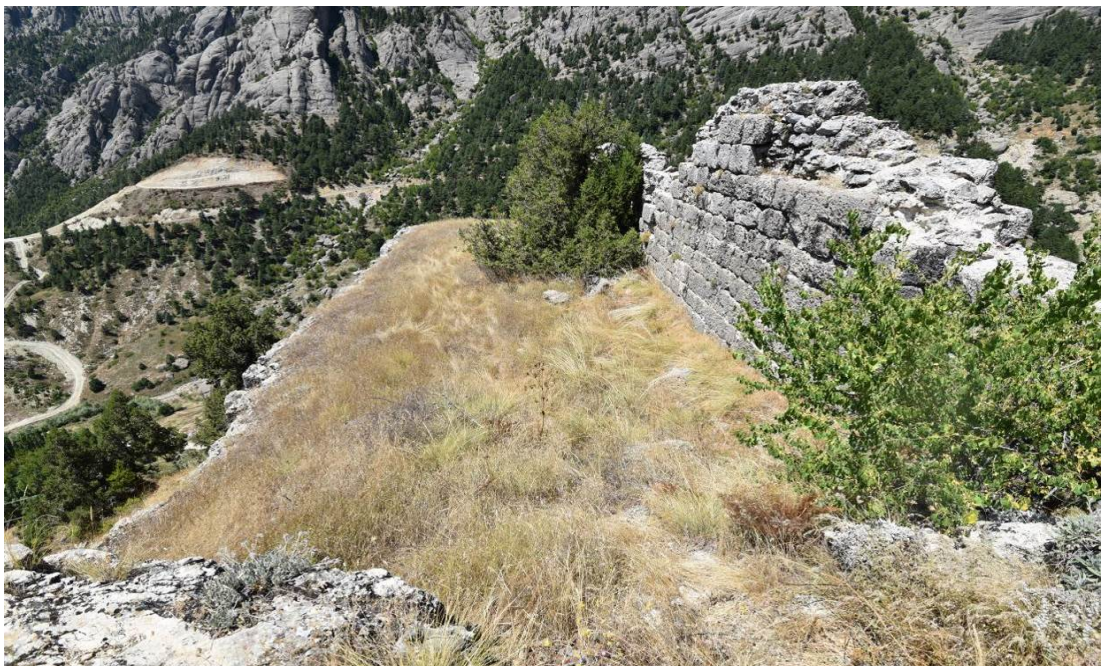
Only the northern wall of this space, which corresponds to the upper part of room 201, has survived. The north wall, which is 26.00m wide and 4.78m tall, is in ruins. The floor of the place is covered with plants and trees and we do not know about the flooring.

**Figure 3.46:** Structure C Space No. 301

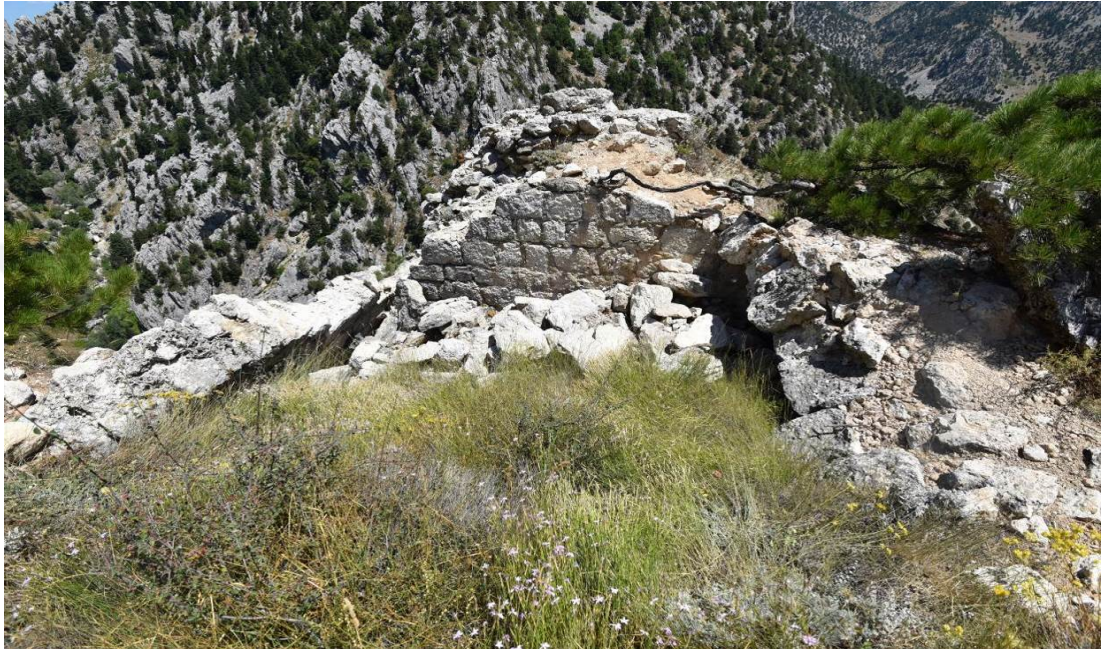
In the circular form that corresponds to the east of the upper part of Room 202, the walls of this room were demolished and a vaulted structure remains on the floor. This section is completely demolished and the northern wall is more standing than the other walls. The stones forming the structure are scattered in the space. The floor of the place is covered with bushes, trees and stones falling from the walls.

**Figure 3.47:** Structure C Space No. 302

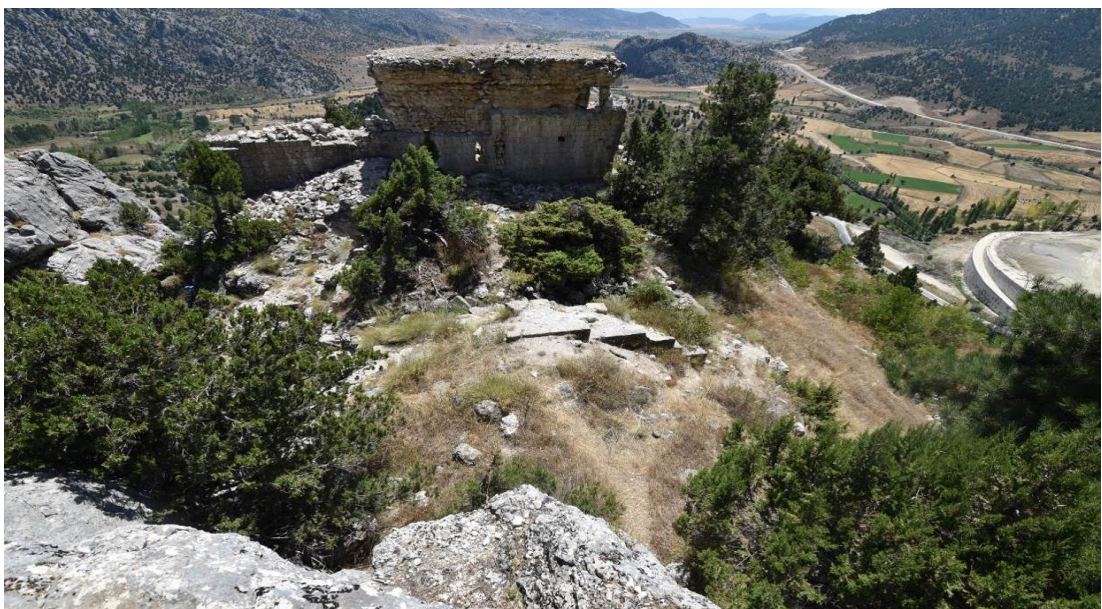
**Figure 3.48:** Structure D Overview

The ground level of the building is 4.53X8.40m in the western part of the building D, which has a basic level but it is full of woody plants, trees and stones and rubble piles. The building is in ruins.

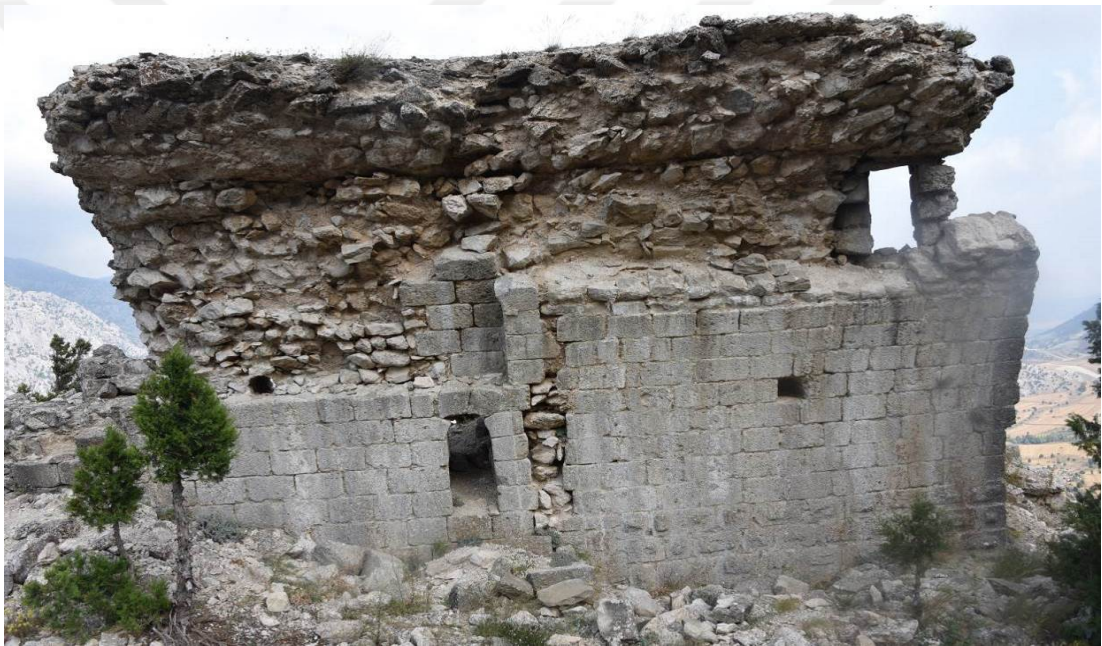
The eastern wall of the interior is standing and the western wall of this section is completely destroyed. The vault cover system of the place is partially standing and the stones falling from the structure are filled with the interior. On the inner eastern wall there is a 0.44X1.17m aperture close to the rectangle (door opening) and another square close to the square (window aperture) measuring 0.83X0.98m at a height of 3.82m above the base level. The floor of the building was filled with rubble.

**Figure 3.49:** Structure D Western Front

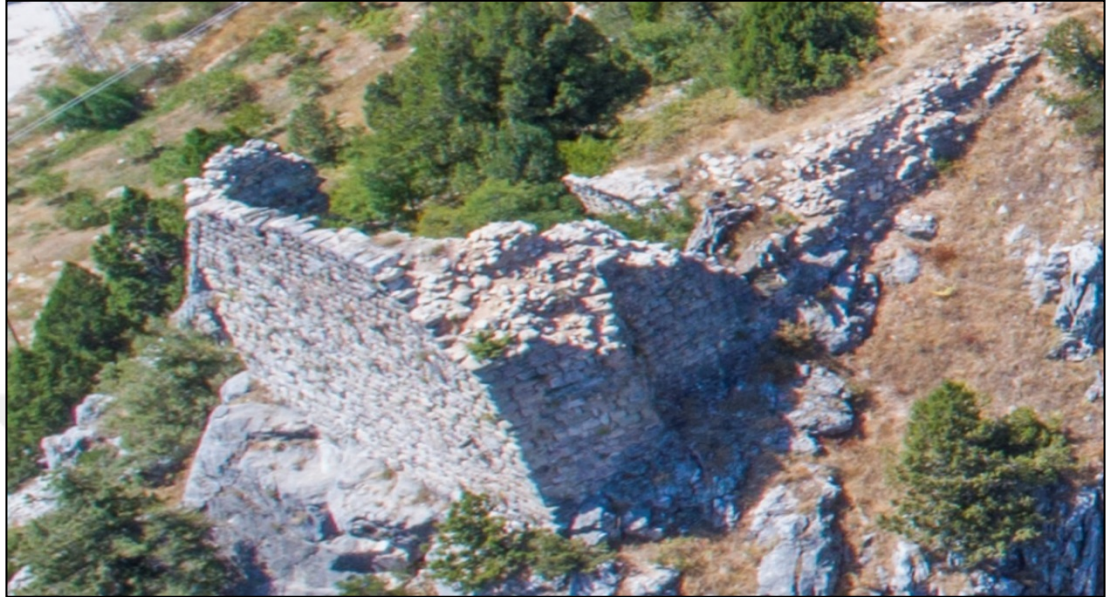
**Figure 4.1:** A Structure Drone Appearance

Structure A It is the standing place at the southern end of the castle (at the eastern corner). The southern wall is the most surviving element of the structure, which has lost its vault and lost its indoor character. There are also wall fragments in the east and west parts to support this wall. However, due to the collapse of the inner wall and vault body of this southern wall, the internal debris was exposed and the outer wall joints were exposed to serious losses, so the wall was not able to withstand off-plane movement against seismic loads. In the following sections, it can be questioned by analytical modeling how this wall performs out of plane with wide aperture. Supporting the partial integrity of the structure with the completions in the vertical walls will limit this behavior. At the same time, the completion of the joints will increase the cross-sectional area of the wall behavior. Thus, wall stresses can show a more healthy distribution.

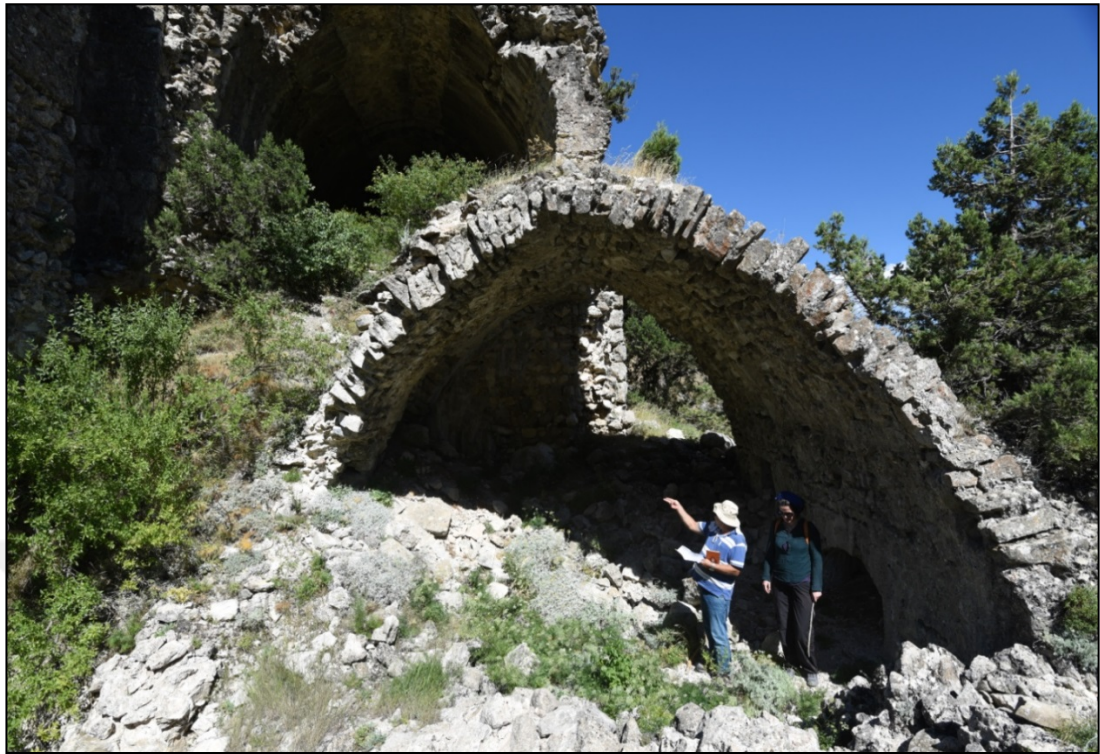
**Figure 4.2:** B Structure West Respect Appearance

Structure B is a flat vaulted structure over a relatively more debris cover in the area. The thickness of the intrados mortar joints of the structure, which is made of vaulted braided stones, varies between 3-10 cm. Therefore, it can be said that the push line of the structure has changed with the loss of the materials which are exposed to external effects for years for the intrados joints located above the original push line. It can be said that the thrust line is transformed into the form where it is along the remaining contact surfaces, not along the side surfaces of all belt stones. As the contact surface becomes narrower, the risk of deterioration of the structure will be greater day by day. On the other hand, the fact that the structure has already been exposed to severe collapses and that the external rubble and coating lines have been lost is an indication that the rubble residue in the extradate melts day by day. Even the completion of the joints by the intervention of the structure will leave the contribution of the stabile superficially even if the structure is not completely lifted up. Therefore, it is also possible to provide a more secure static consolidation of the structure by temporarily installing an under-arched scaffold so that the spread contact to the under-arch can be stabilized without changing the load transfer terminology.

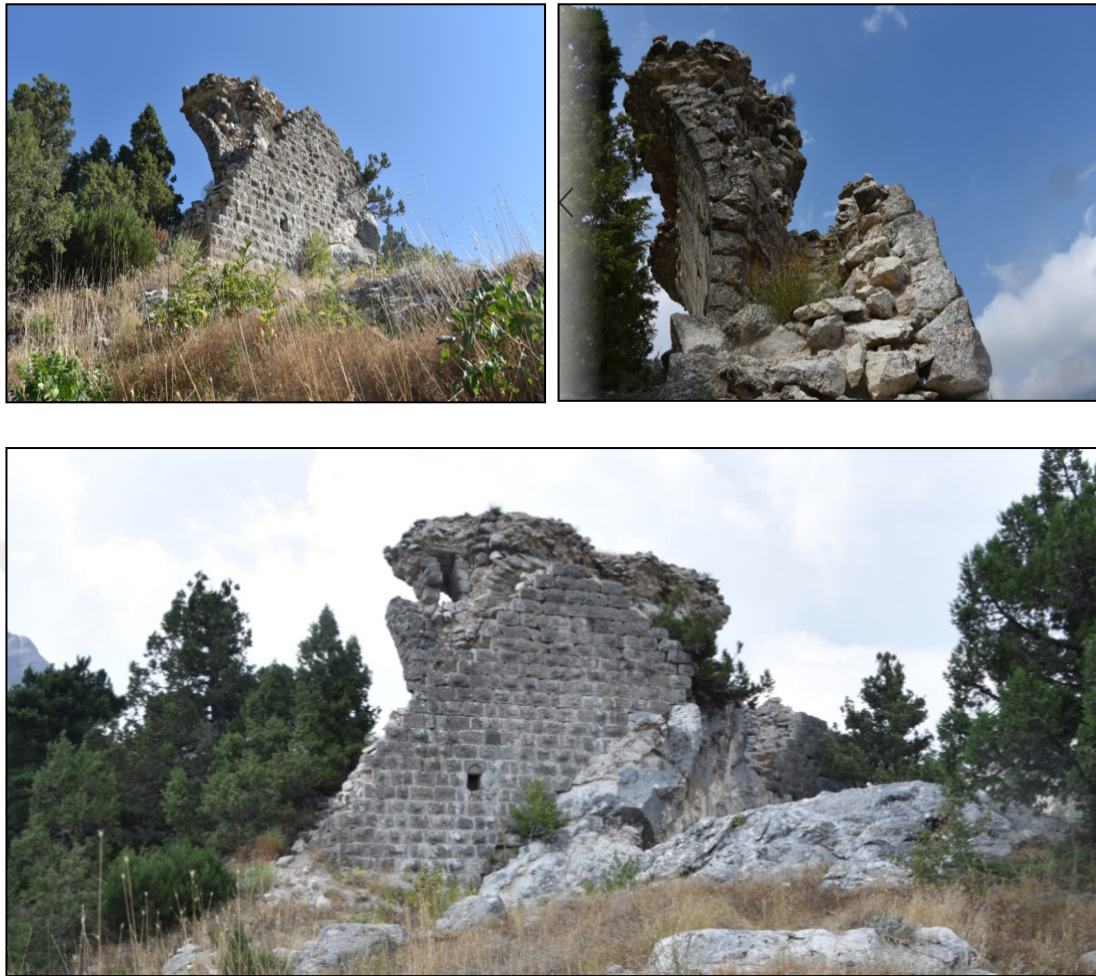
**Figure 4.4:** D Structure Facade appearances

Structure D It consists of the southern wall of a large room and the remaining part of the vault quarter. Therefore, there are consoles in both vertical and parallel corners of the structure. The inner and outer walls of the structure, starting from the edges, remain exposed to the external influences, especially in the form of vaults. The trace of the deformation of the structure starting from the upper elevations towards the lower elevations is clearly seen. Neither the outer walls nor the internal debris were detected at the lower elevations and at the basement level. However, today the structure is a geometry that includes a large percentage of its mass at its upper elevations. Therefore, earthquake loads will cause serious damages in the later stages of the structure. It is essential that the structure is stabilized, complemented and, if necessary, supported by a removable scaffold system.

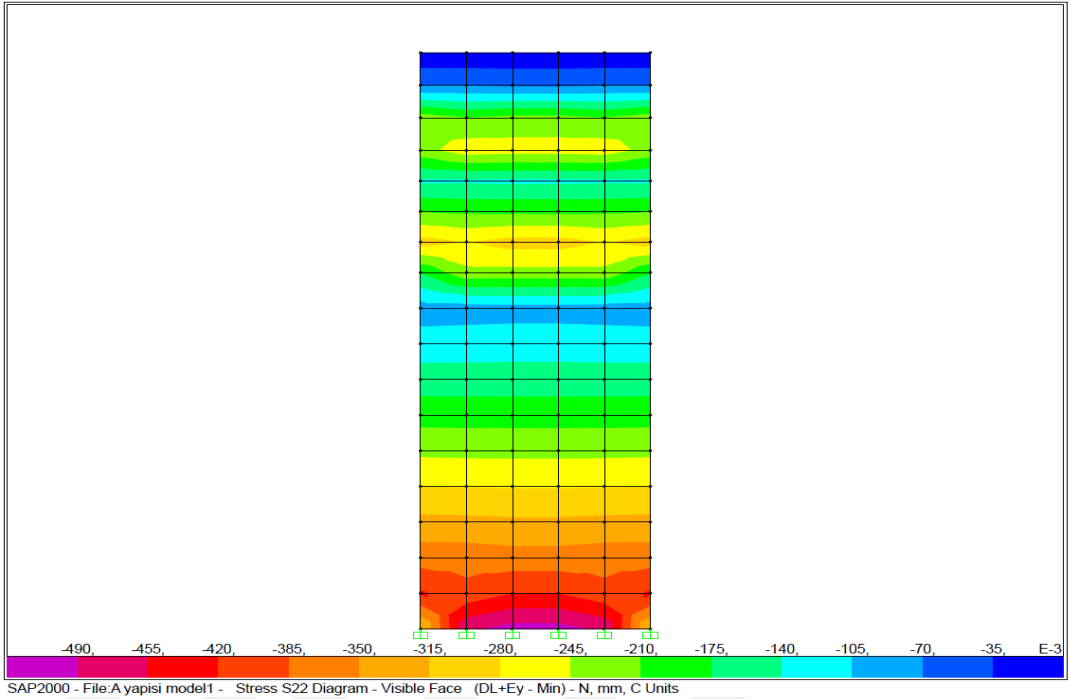
**Figure 5.6:** Vertical stress distribution (pressure stresses) on the wall under Wall G + O Combination (wall cross-section shown)

According to the results of the analysis, the pressure stresses in the wall remain in the order of 0.5 MPa (wall level). No additional stress was observed in the sections where the wall cross-section changed.

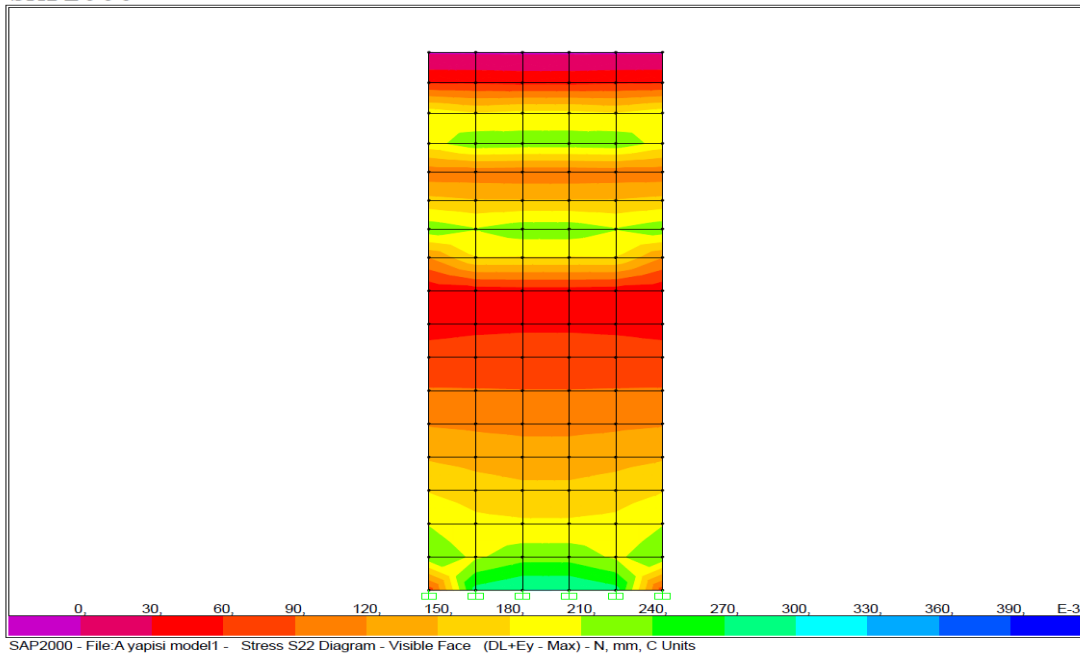
**Figure 5.7:** Vertical stress distribution (tensile stresses) in the wall under Wall G + O Combination (wall cross-section changes shown)

According to the results of the analysis, the tensile stresses that will occur in the wall are in the order of 0.3 MPa (at the wall base level and the sections where the wall cross-section changes).

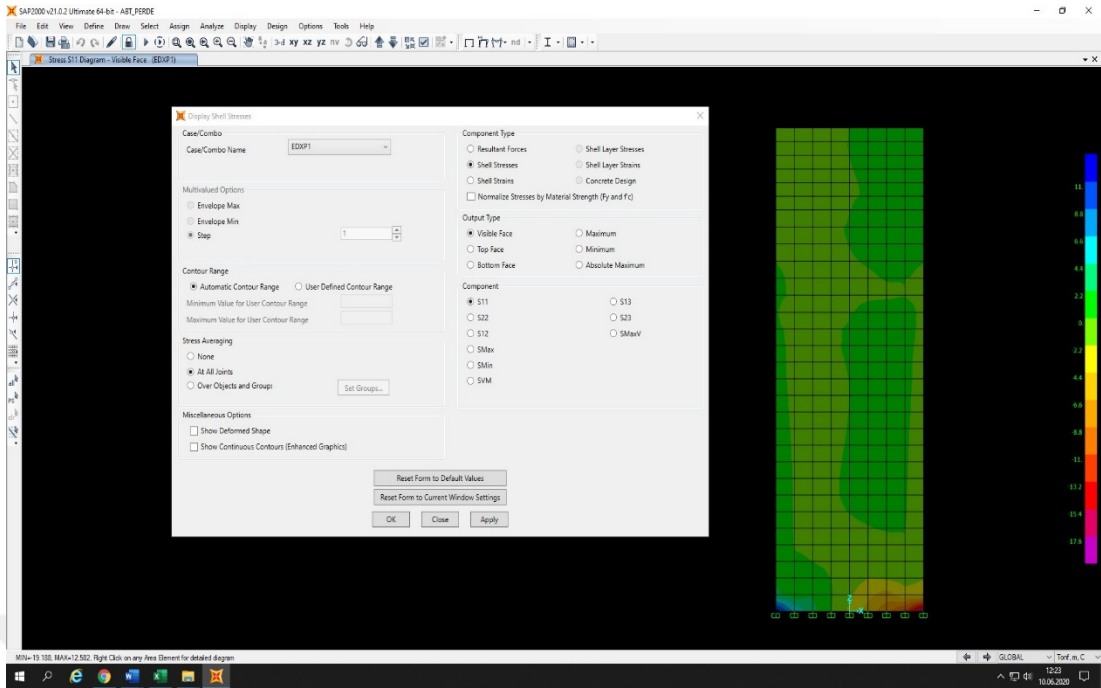
**Figure 5.34: Stress S11 Diagram- Visible Face (EDXP1)**

However, as it is seen in the current situation of the structure, there is spillage, emptying and deterioration in the mortars between the rubble stones. Since the analysis model does not include material problems due to the current condition of the wall, at least the necessary repairs should be made to the wall part.
